## Clattering noise from underbody/exhaust system, vibrations after cold start

| Topic number | LI49.00-P-067579 |
| Validity | Model 213.#88//#89 |

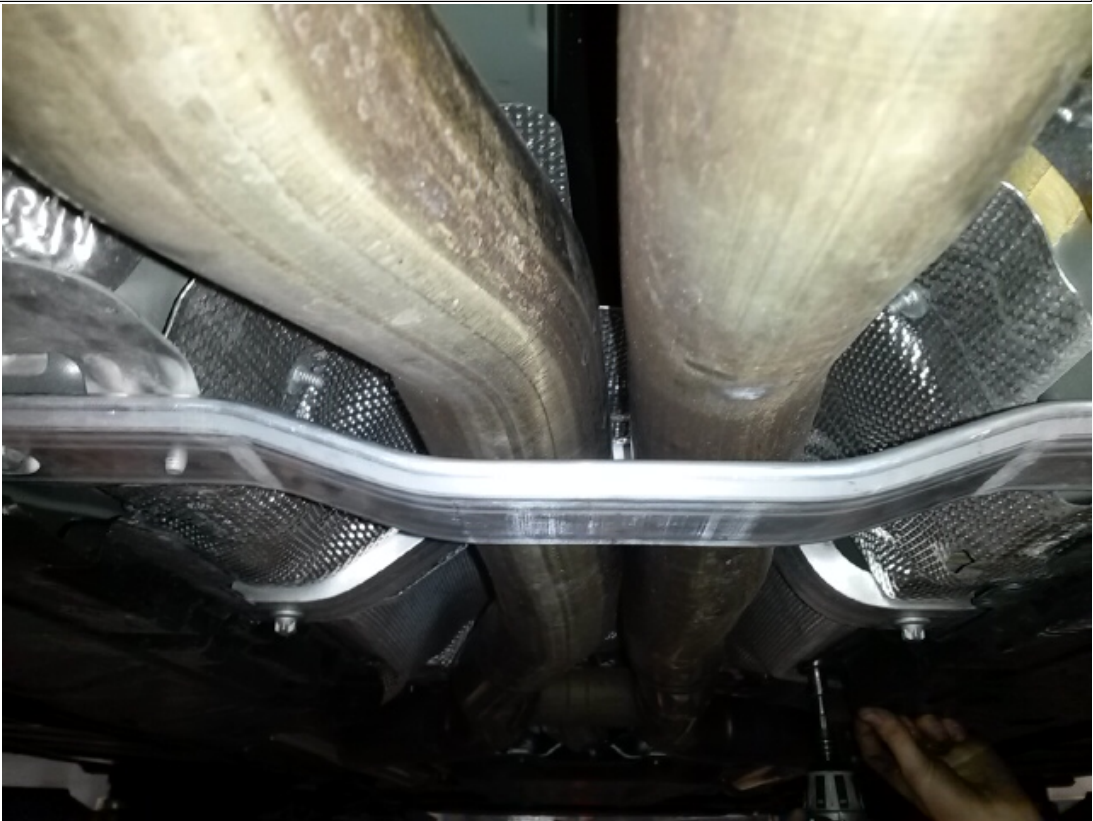
082557.jpg:

Reinforcement under exhaust system in vehicle center.

| Attachments | |
|---|---|
| 082557.jpg | Specified status of bent reinforcement |

Check installed reinforcement

SPECIFIED: Bent reinforcement with part number A 213 619 2500 (see pictures in attachment)

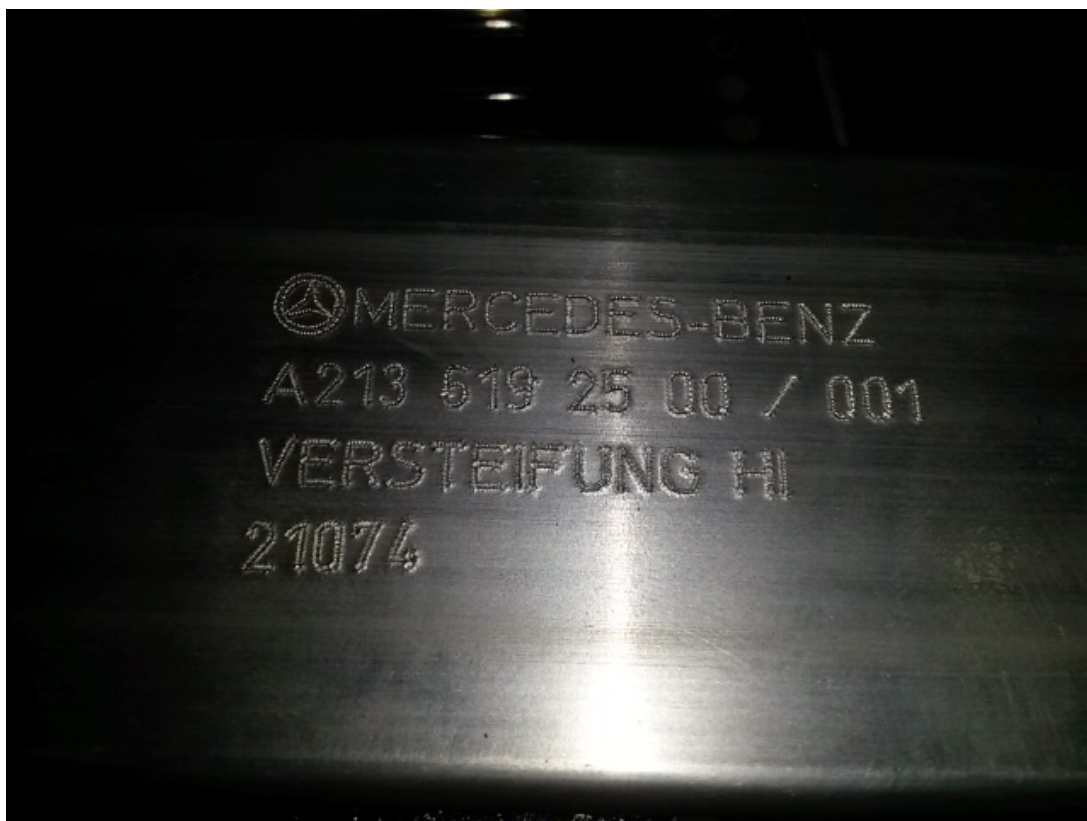
081800.jpg:

| Attachments | |
|---|---|
| 081800.jpg | Specified status of reinforcement part number |
