## Floor covering on front passenger side at center console too short

| Topic number | LI68.30-P-067589 |
| Validity | C238 / A238<br>Up to production date 15.06.2017 |

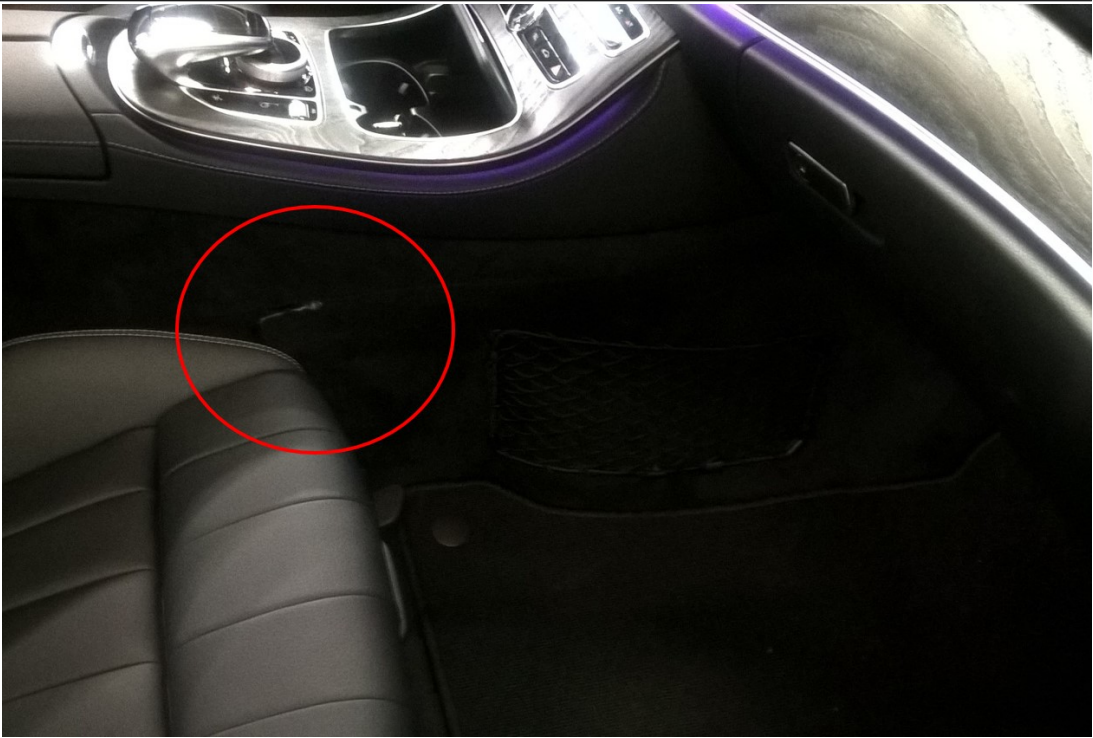
pic 1.jpg:

Floor covering on front passenger side at center console too short.

| Attachments | |
|---|---|
| pic 1.jpg | Overview of damage profile |

Floor covering on front passenger side at center console was built too short.

Replace floor covering on front passenger side.

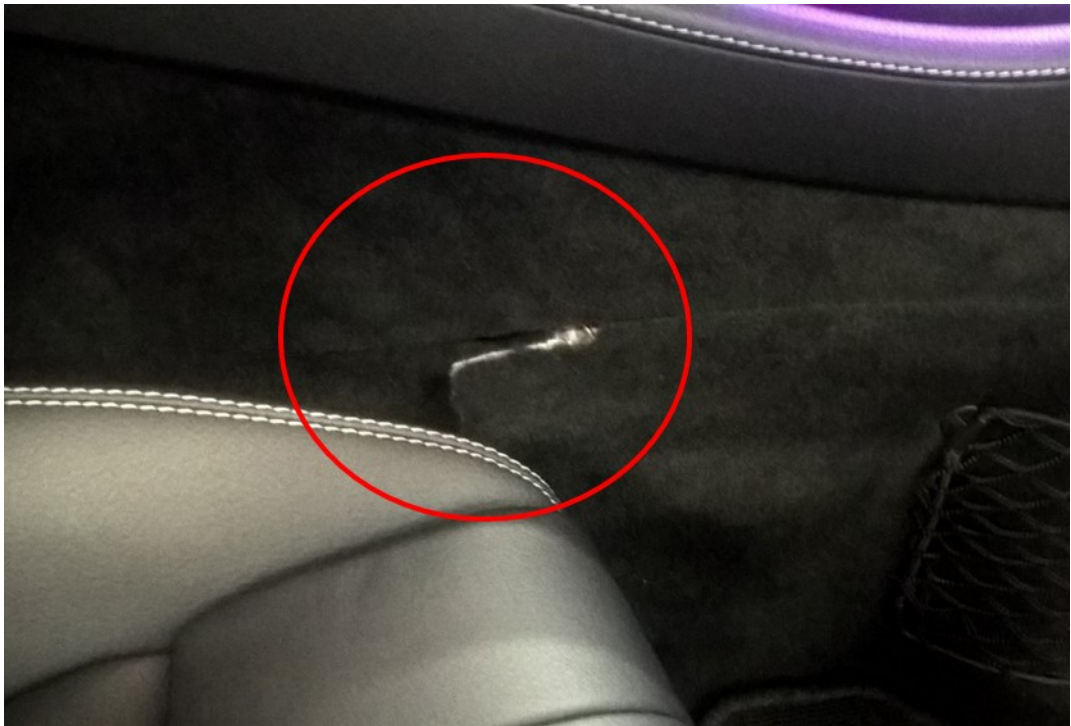
pic 2.jpg:

| Attachments | |
|---|---|
| pic 2.jpg | Detailed view of damage profile |
