## OM642 Exhaust Bracket Cracking

| Topic number | LI49.10-N-067486 |
| Validity | Sprinter Model 906 with engine OM642 |

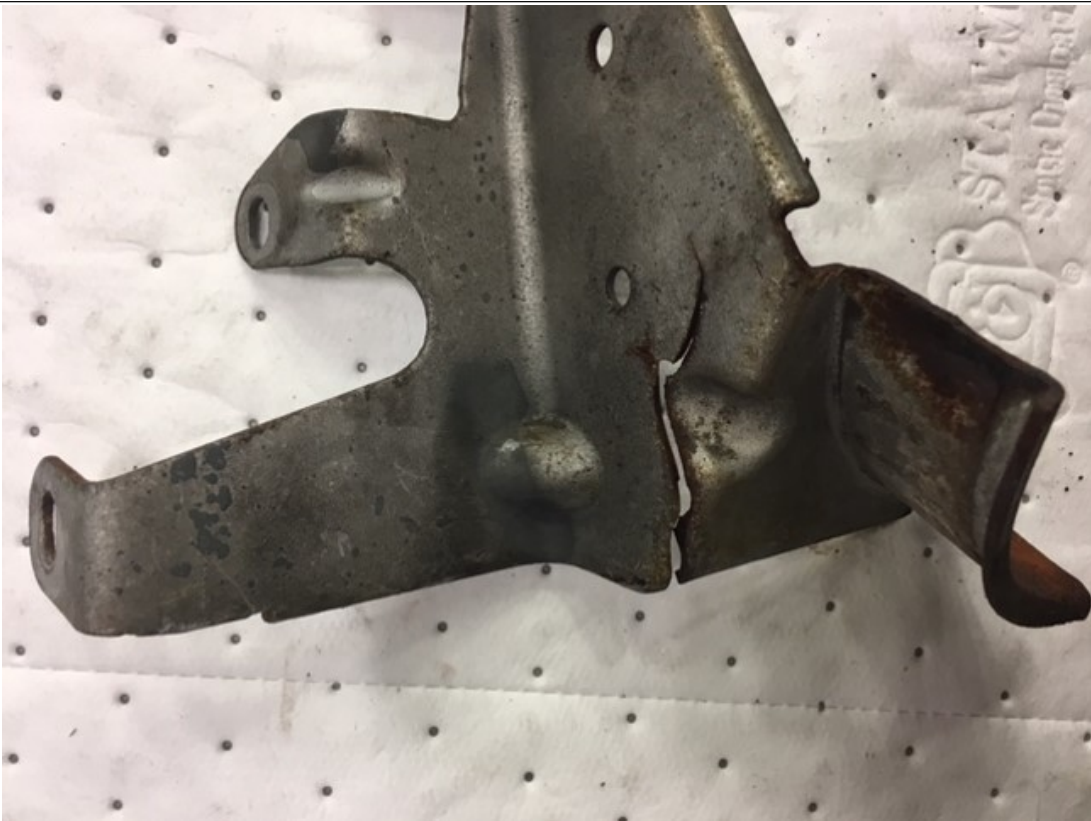
CrackedDPFBracket.jpg:

Exhaust Bracket to Transmission Cracked/Broken (Pic. 1)

| Attachments | |
|---|---|
| CrackedDPFBracket.jpg | Cracked DPF bracket. |

#1 - Inspect exhaust bracket securing DPF to Transmission bell housing for cracks as shown in pic. 1. If crack is present, replace component with newest part number. Ensure new bracket has additional structure (pic. 2).

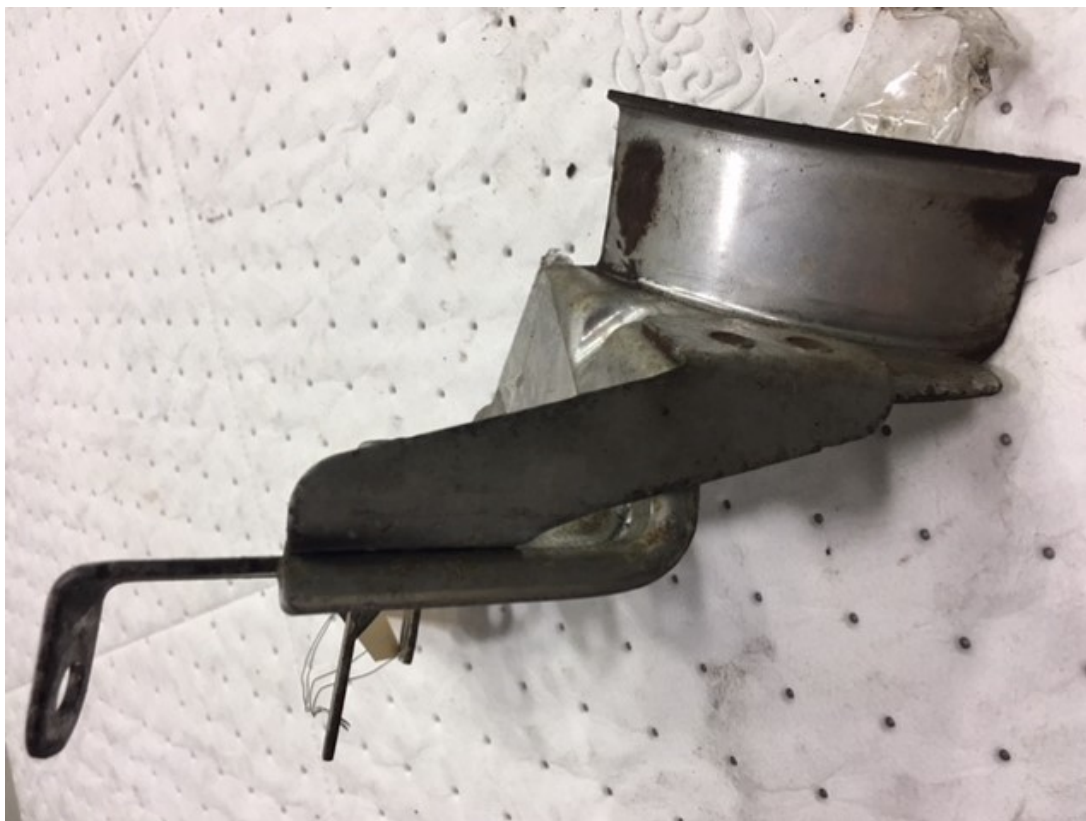
NewBracket.jpg:

| Attachments | |
|---|---|
| NewBracket.jpg | New DPF bracket with additional structure. |

| Part number | ES1 | ES2 | Designation | Quantity | Note | EPC |
|---|---|---|---|---|---|---|
| A 906 492 69 41 | | | DPF Exhaust Bracket | 1 | Applicable for 4x2 and 4x4 vehicles. | X |
