## Creaking noises from seat cushion length adjustment (SKTE) in vehicles with Memory Package (code 275)

| Topic number | LI91.10-P-067673 |
| Validity | BR 213 with SA code 275 (Memory Package) up to manufacturing date 16.03.2017 |

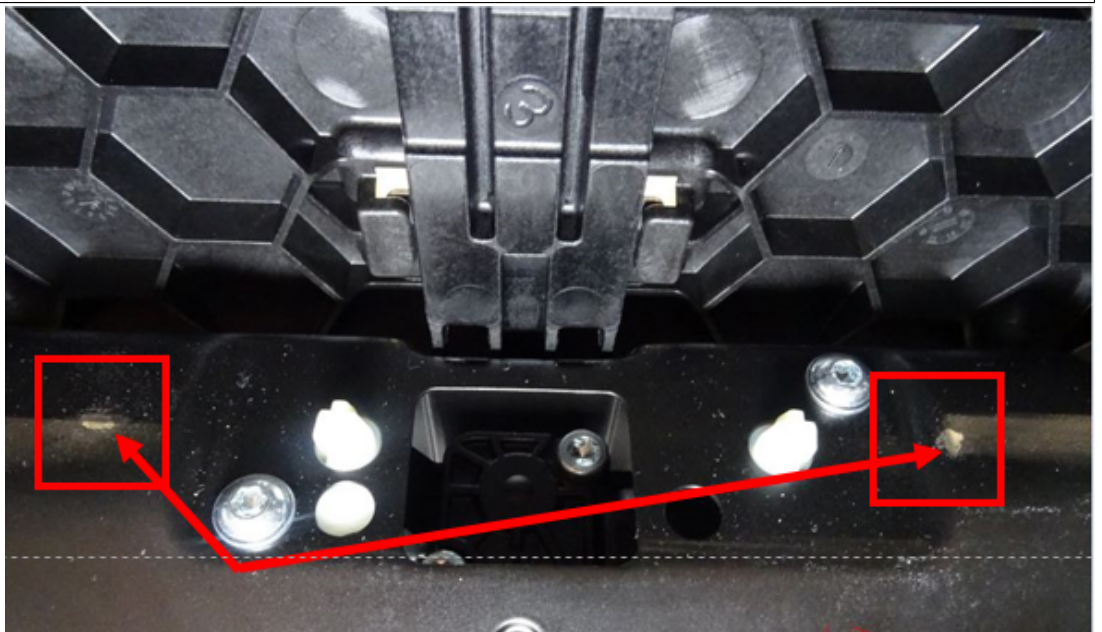
Pic.1.jpg:

Contact between plastic lever of seat cushion and cushion shell (signs of abrasion visible on cushion shell).

| Attachments | |
|---|---|
| Pic.1.jpg | Signs of abrasion on cushion shell. No felt attached. |

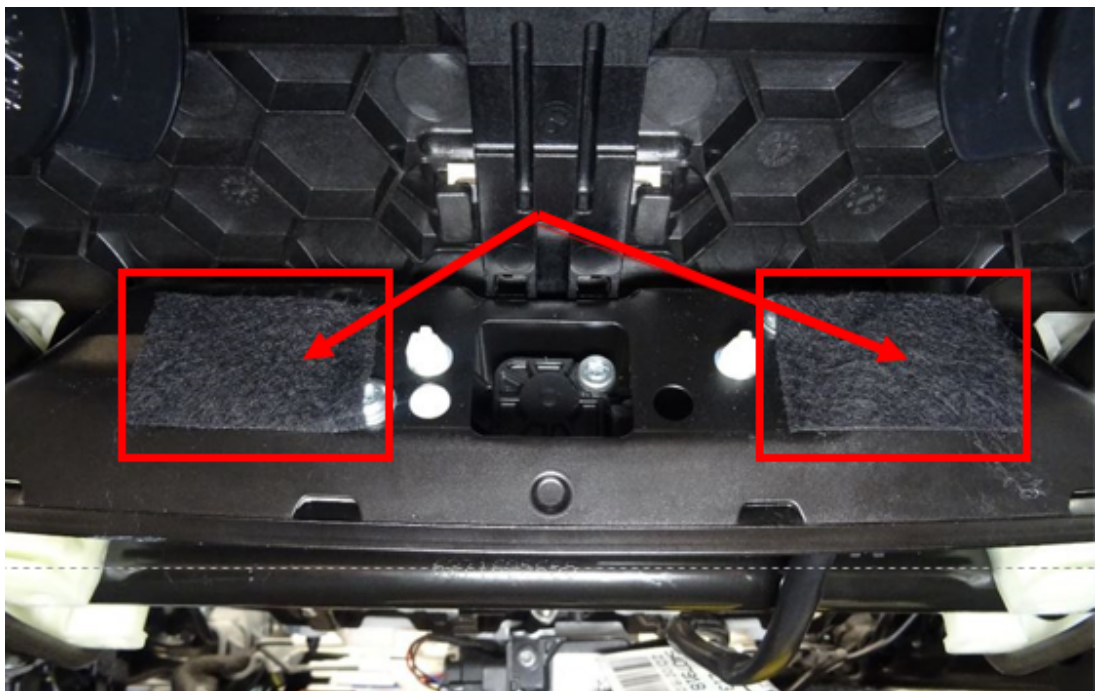
Pic.2.jpg:

| Attachments | |
|---|---|
| Pic.2.jpg | Felt strips attached to cushion shell. |

- Stick felt strips (approx. 10x8 cm) onto cushion shell of seat (see pictures, illustrated without the SKTE lever). It is not necessary to remove the seat for this.
