## Noises from upper instrument panel cover (centerfill grille) BR213, BR238

| Topic number | LI68.10-P-064592 |
| Function group | 68.10 Instrument panel |
| Date | 02-08-2018 |

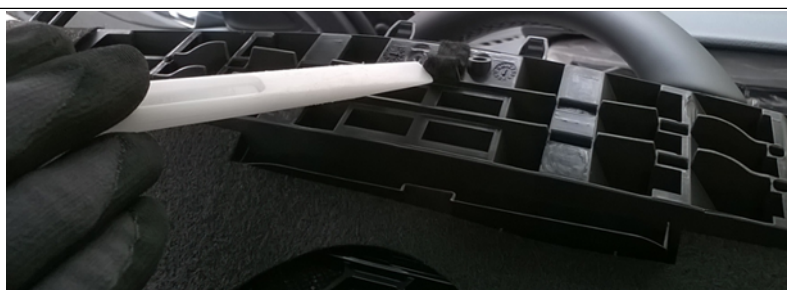
Abdeckung Instrumententafel oben Pic.1.JPG:

Covering makes contact with instrument panel

| Attachments | |
|---|---|
| Abdeckung Instrumententafel oben Pic.1.JPG | A rib is located at this point on the component. A 10x2x25 mm piece of felt must be fitted over this rib. |

Cut felt to size 10X25 mm.

Apply felt to marked area (Pic. 1).
