## Complaints about noises or poor windshield wiper wiping performance

| Topic number | LI82.30-P-059239 |
| Function group | 82.30 Windshield wipers |
| Validity | All passenger car model series |

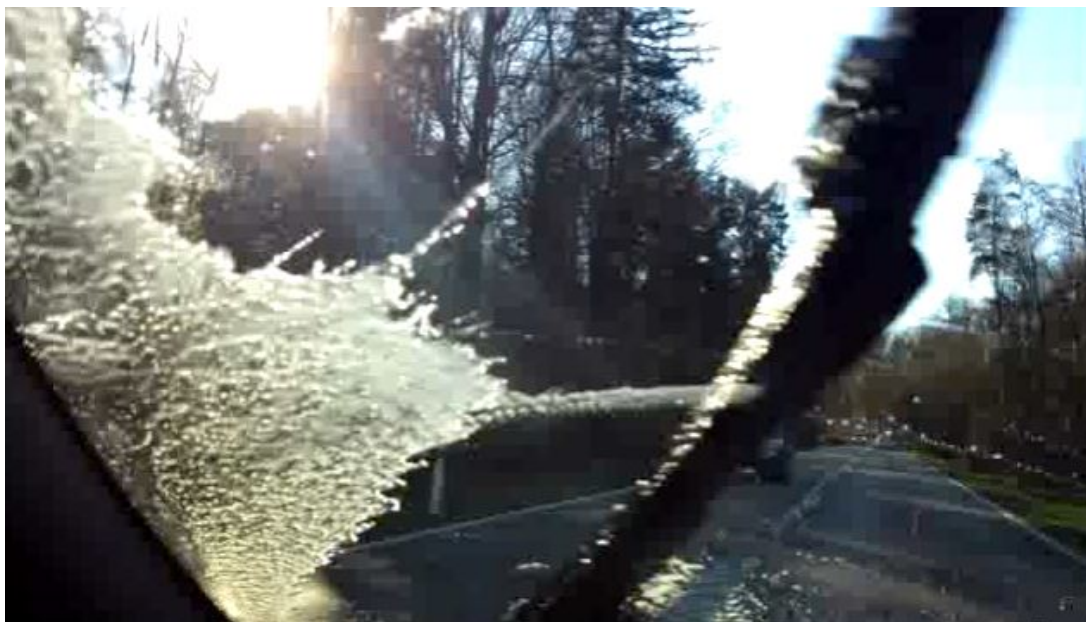
Bild 1.JPG:

D: During downward movement, water is pulled back onto the windshield from the A-pillar (picture 1)

| Attachments | |
|---|---|
| Bild 1.JPG | During the downward movement water is pulled back onto the windshield from the A-pillar |

Water is pulled back onto the windshield by the differential pressure created as the wiper arm moves downwards.

This is a normal operating condition.

Exception: X204 up to 02/2014. In these vehicles it is possible to install the design configuration of vehicles as of 02/2014. This includes wiper arms (styled arms) with improved behavior in this respect. It is also necessary to replace the wiper blades because the styled arms feature a Top Lock connection (previously Side Lock). When installing the passenger-side wiper arm, observe the new park position (21 mm) via the marking on the windshield (Figure 4).

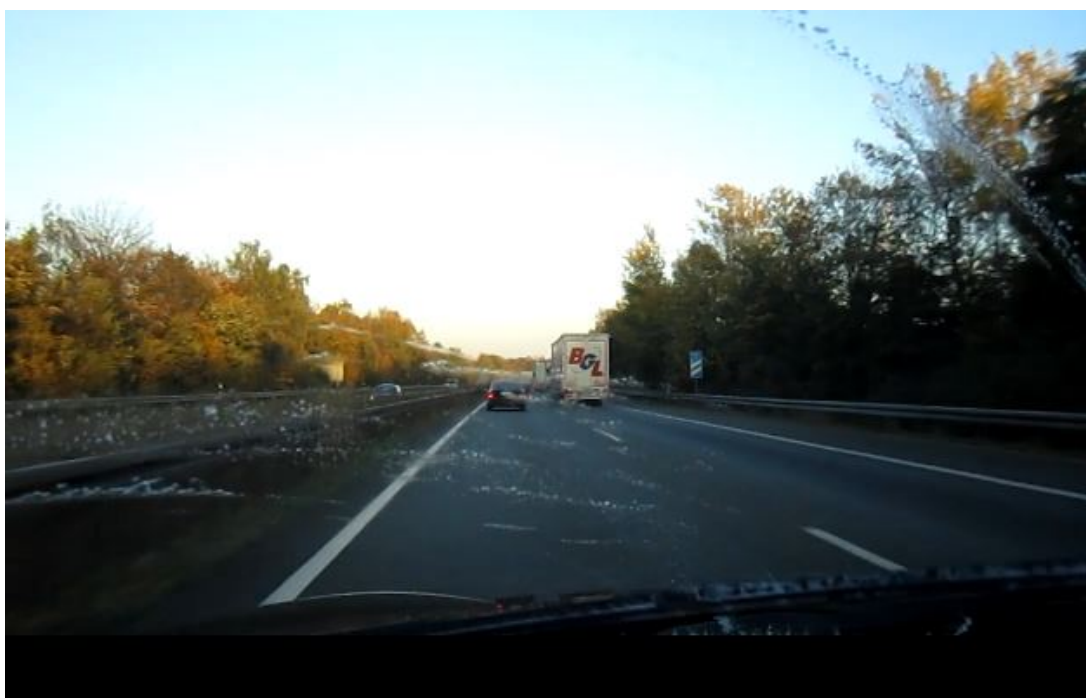
Bild 2.JPG:

E: After windshield cleaning, water keeps spraying onto the windshield for several wipe cycles (picture 2)

| Attachments | |
|---|---|
| Bild 2.JPG | After windshield cleaning, water keeps spraying onto the windshield for several wipe cycles |

Washer water collects in the fastening of the wiper blade and is blown onto the windshield by the airstream over several wipe cycles.

This is normal operating condition

Exception: Model series 204 C-Class and model series 207. On these vehicles the wiper blades of the model series 212 can be used to improve the situation.

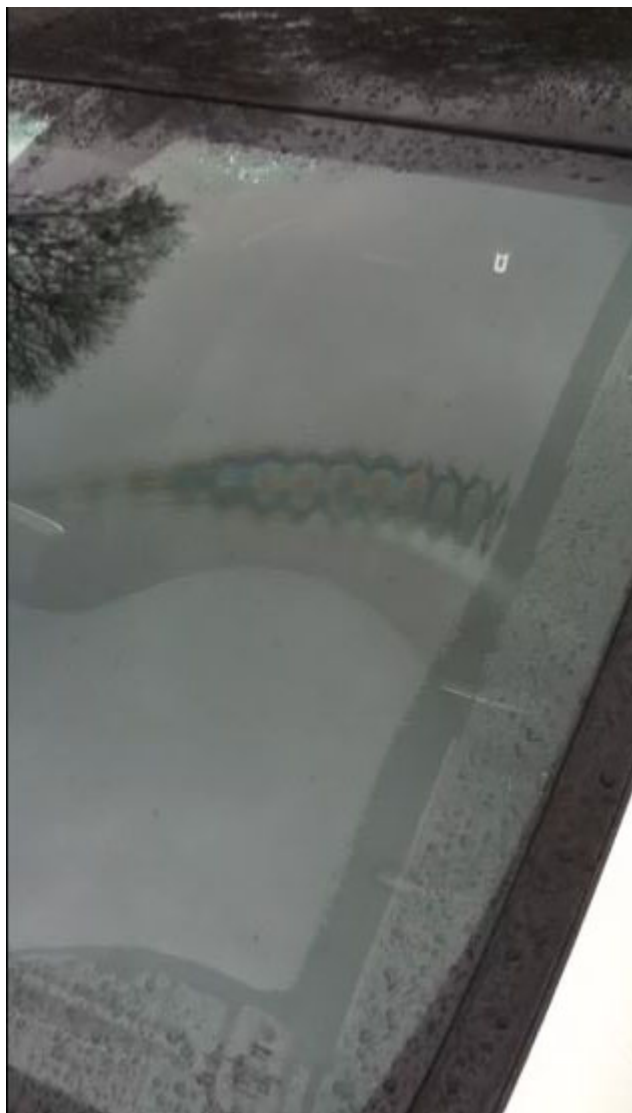
Bild 3.JPG:

| Attachments | |
|---|---|
| Bild 3.JPG | Streaking due to excessive downforce of the wiper arm |

C3: Clamping force of wiper arm not OK (picture 3)

C3: Check wiper arm for sluggishness in the bearing. Restore mobility or replace wiper arm if necessary.

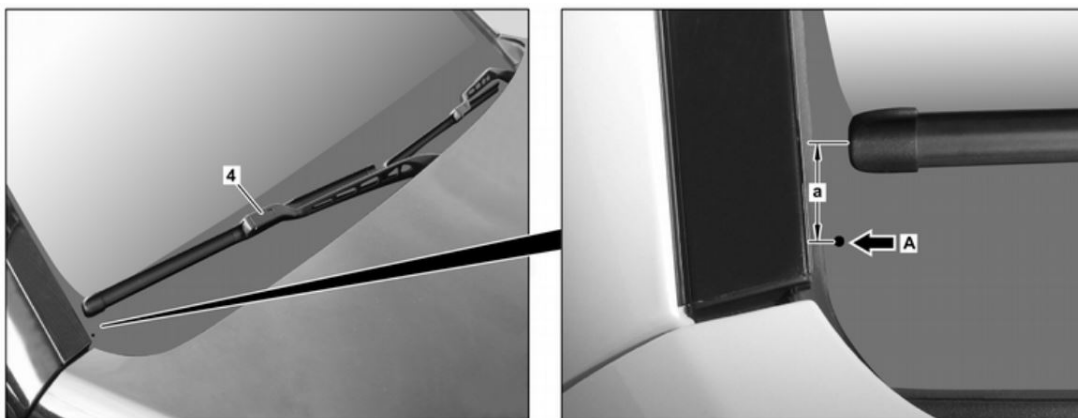
Bild 4.JPG:

| Attachments | |
|---|---|
| Bild 4.JPG | Park position of tip of blade on X204 passenger-side wiper arm with Top Lock |
