## Creaking noises at seat when cornering (left side of seat)

| Topic number | LI91.10-P-067712 |
| Function group | 91.10 Front seats |
| Validity | BR 213: Up to 09.01.2018 (WDD2130421A409095)<br>BR 205, 253: Up to 19.12.2017 (WDC2539891F394735)<br>BR 257: Up to 08.01.2018 (WDD2573591A000497) |

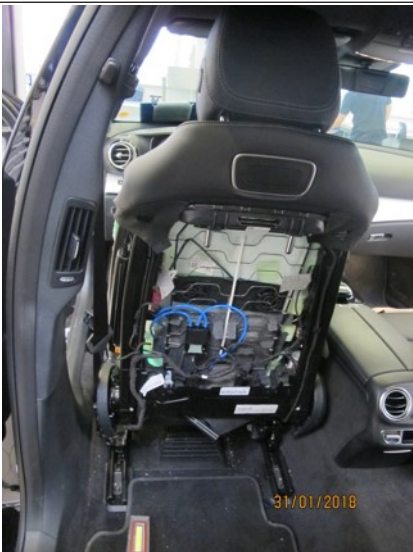
Pic.1.jpg:

| Attachments | |
|---|---|
| Pic.1.jpg | Removing the seat-back lining |

- Raise the seat all the way up.
- Detach the seat-back lining (Pic.1).
- Detach the seat cover from the backrest frame on the left side of the seat (Pic.2).
- Push the detached seat cover and the seat cushion to the side in order to expose the affected area (Pic.3).
- Check the area between the backrest member and the lower crossmember using a feeler gauge of thickness .040mm (Pic.4, 5):

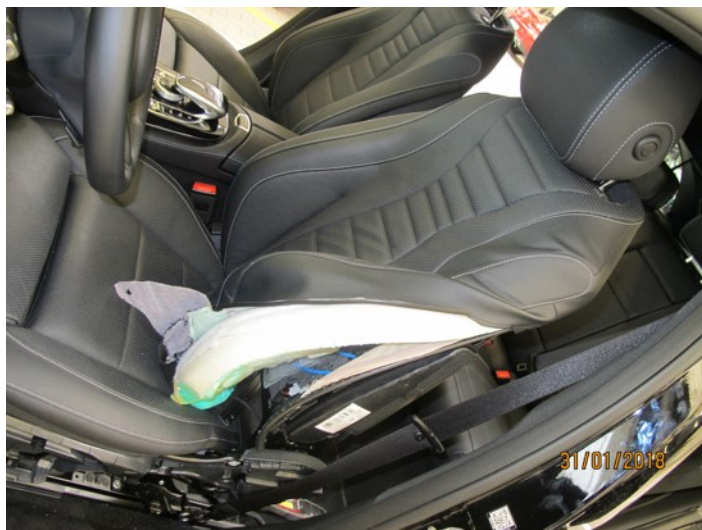
Pic.2.jpg:

| Attachments | |
|---|---|
| Pic.2.jpg | Detaching the seat cover on the left side of the seat |

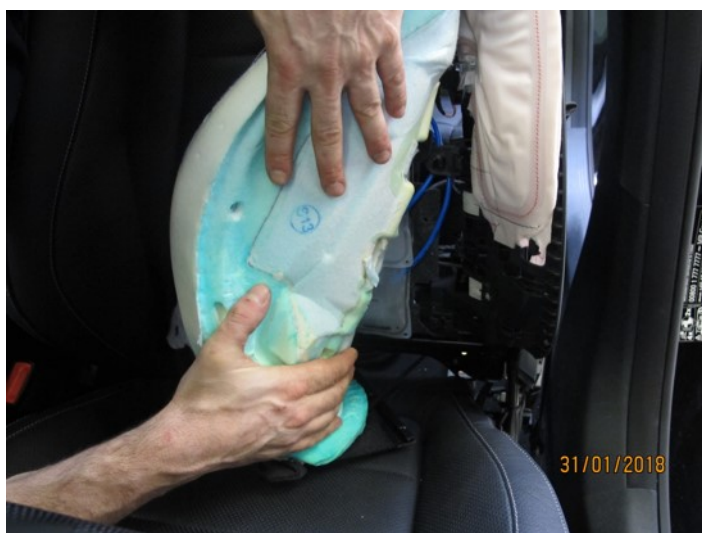
Pic.3.jpg:

A burr at the bottom of the backrest member may cause contact with the lower crossmember. This produces a noise when the two components move.

| Attachments | |
|---|---|
| Pic.3.jpg | Affected area |

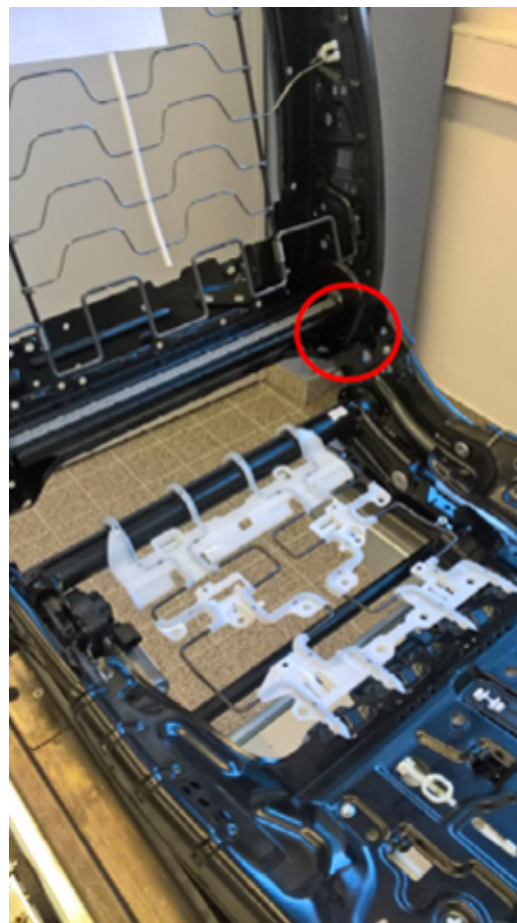
Pic.4.jpg:

| Attachments | |
|---|---|
| Pic.4.jpg | Illustration of affected area |

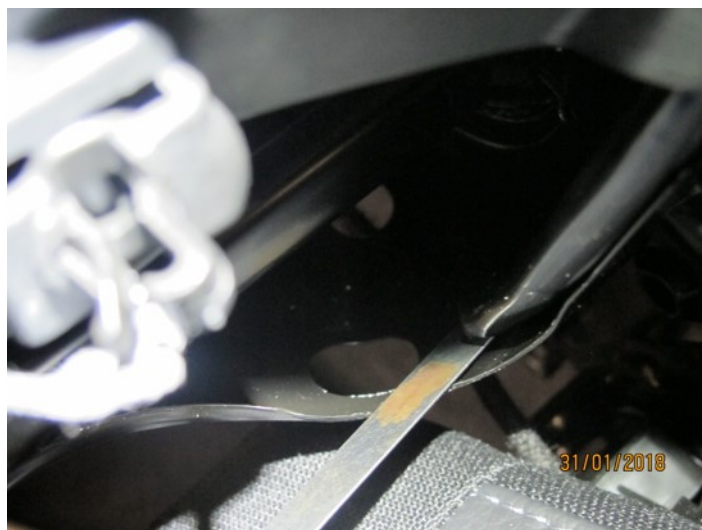
Pic.5.jpg:

| Attachments | |
|---|---|
| Pic.5.jpg | Measuring the area with a size 40 feeler gauge |

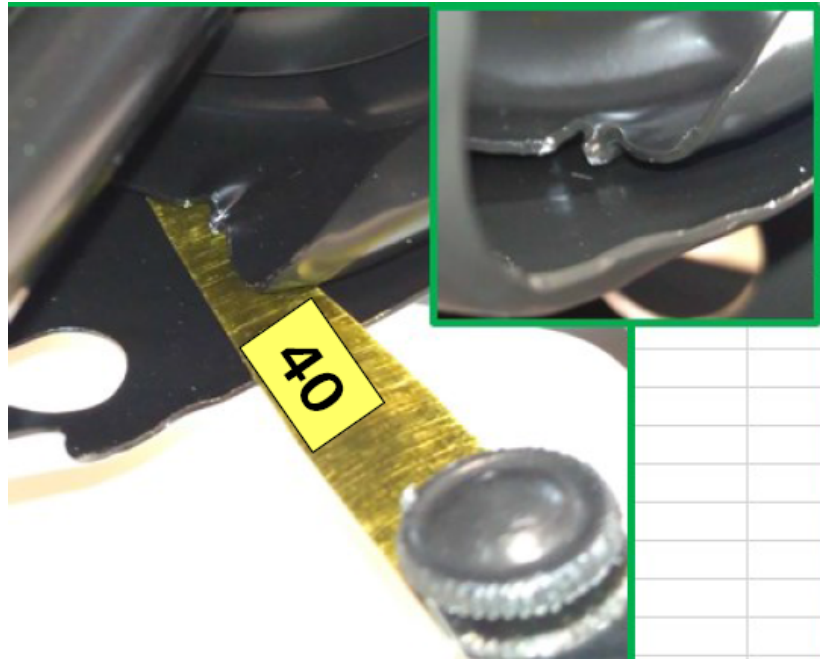
Pic.6 i.O. Teil.jpg:

Result OK: The gauge passes through the area (Pic.6) - The cause of the noise complaint does not lie in the affected area. End of test.

| Attachments | |
|---|---|
| Pic.6 i.O. Teil.jpg | Illustration of OK check |

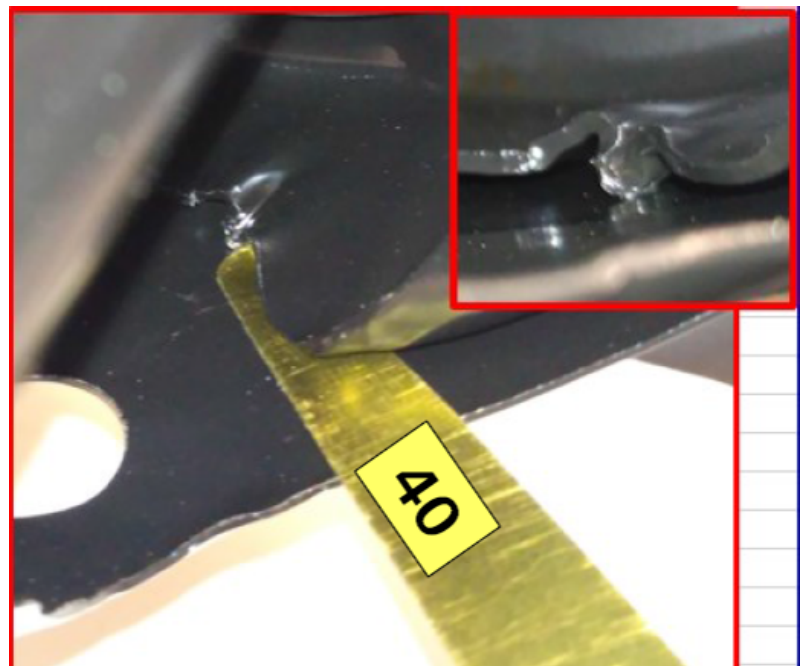
Pic.7 n.i.O. Teil.jpg:

Result not OK: The gauge does not passes through the area (Pic.7) - Modify the seat backrest frame.

| Attachments | |
|---|---|
| Pic.7 n.i.O. Teil.jpg | Illustration of not OK check |

- Enlarge the area between the backrest member and the lower crossmember by moving a screwdriver (5.5 mm) up and down (Pic.8).
- Check whether a feeler gauge of thickness .040mm can be passed through the affected area (Pic.9). Enlarge the area more if necessary.

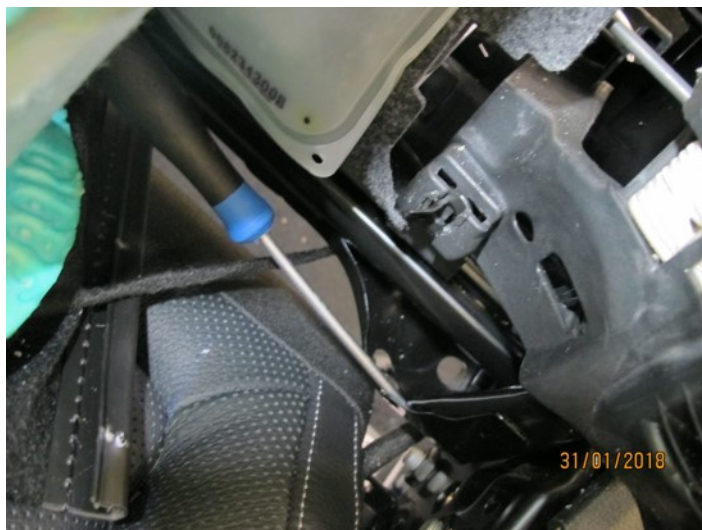
Pic.8.jpg:

| Attachments | |
|---|---|
| Pic.8.jpg | Enlarging the gap using a screwdriver |

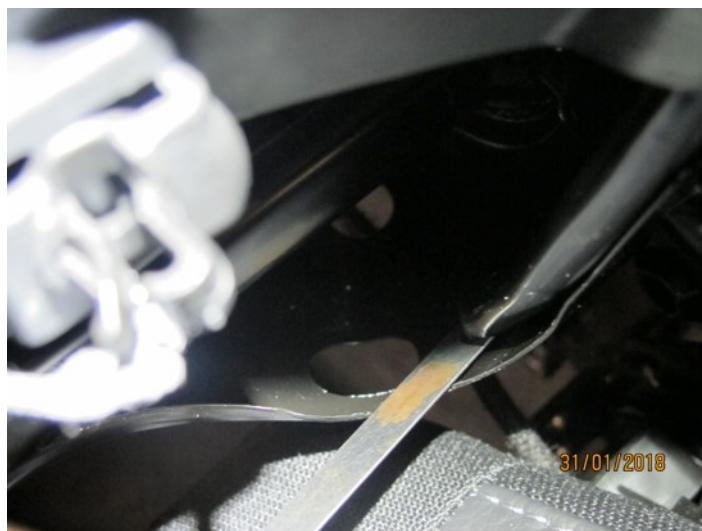
Pic.9.jpg:

| Attachments | |
|---|---|
| Pic.9.jpg | Final measurement |
