SI M54 04 17
Special Roofs

SERVICE ACTION: REWORKING THE SOFT TOP BOW BEARING

This Service Information bulletin supersedes SI M54 04 17 dated February 2018.

F57 (Cooper, Cooper S, JCW Convertible)			
---	--	--	--

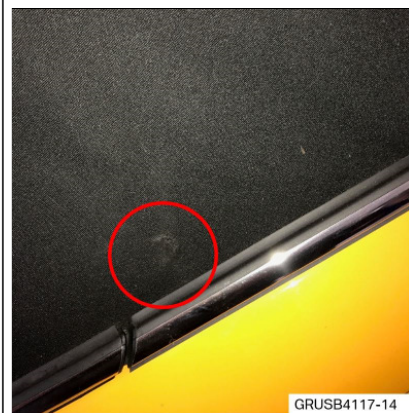
The adjusting element interferes with the soft top and it may or may not cause chafing of the convertible top fabric at the c-pillar area as shown below.

The adjusting element installed in the soft-top bow bearing support may come into contact with the soft top.

Replace the adjusting element with an improved part.
