# NEWMAR CORPORATION

## PRODUCT INFORMATION BULLETIN

| DATE ISSUED | MODEL YEAR(S) AFFECTED | PIB # |
|---|---|---|
| 4/12/2018 | 2018 | 511 |

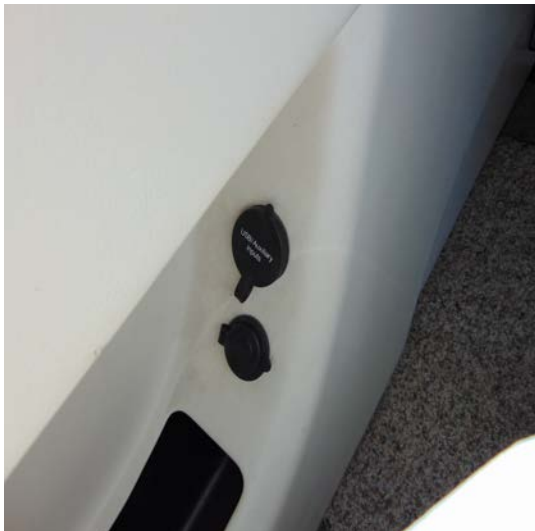
Certain Dash Xite Radio USB Inputs may have been spliced without the shield of the cable properly attached. If affected, the USB ports may not be active as the USB input to the Xite Infotainment center. The affected USB input is normally located on the driver side console

USB Typical Location on Driver Side

Non-working USB cables may be replaced with unmodified cables (Newmar part# 110664) to fix the issue.
