NBT-EVO NEXT GENERATION NAVIGATION PROFESSIONAL HEAD UNIT CANNOT BE SWAPPED BETWEEN VEHICLES FOR TESTING. COMPONENT PROTECTION ACTIVE

This Service Information bulletin supersedes SI M65 06 17 **dated October 2017**.

4.2 * NEW * Head Unit High 2 with fault memory 0xB7F87A - Unblock the component protection with ISTA 4

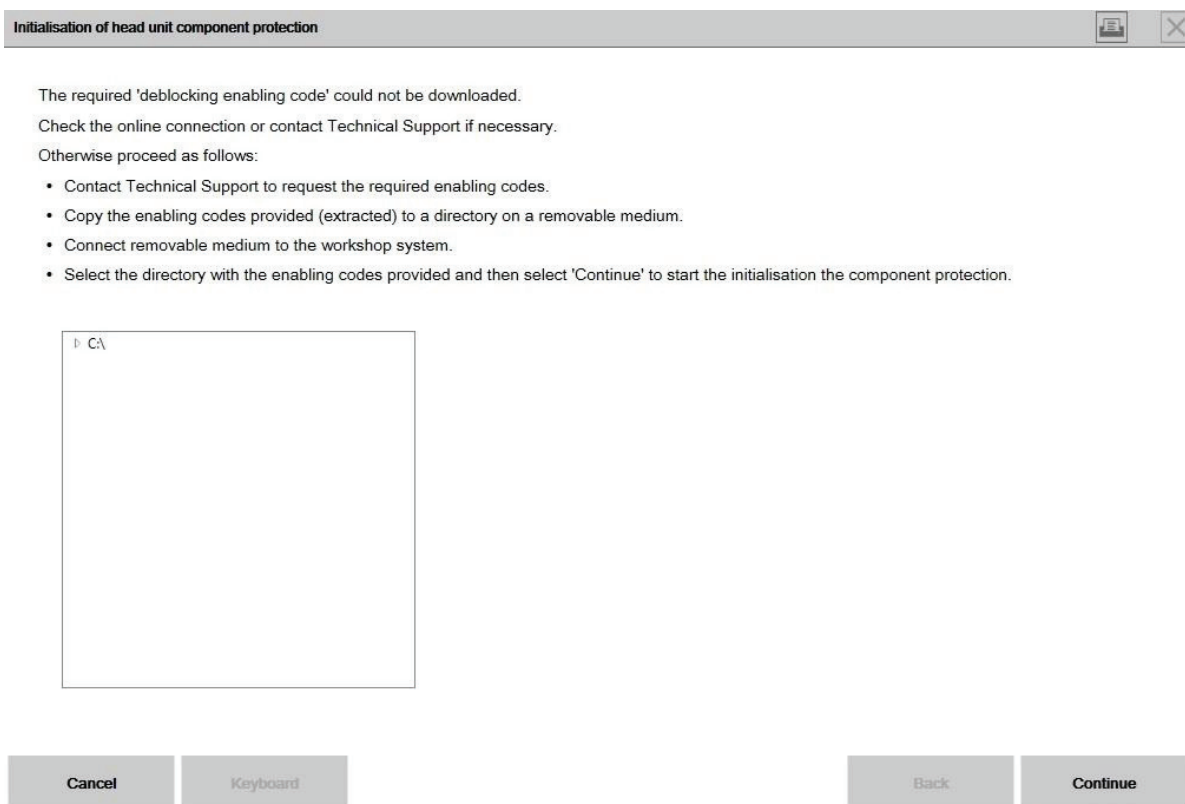
Initialisation of head unit component protection

The required 'deblocking enabling code' could not be downloaded.
Check the online connection or contact Technical Support if necessary.
Otherwise proceed as follows:

13. Select the storage location (folder) of the unpacked enabling codes in the next dialogue.

- Contact Technical Support to request the required enabling codes.
- Copy the enabling codes provided (extracted) to a directory on a removable medium.
- Connect removable medium to the workshop system.
- Select the directory with the enabling codes provided and then select 'Continue' to start the initialisation the component protection.
