US 63250780-04

Bank angle display disappears

K46/12 K46/13

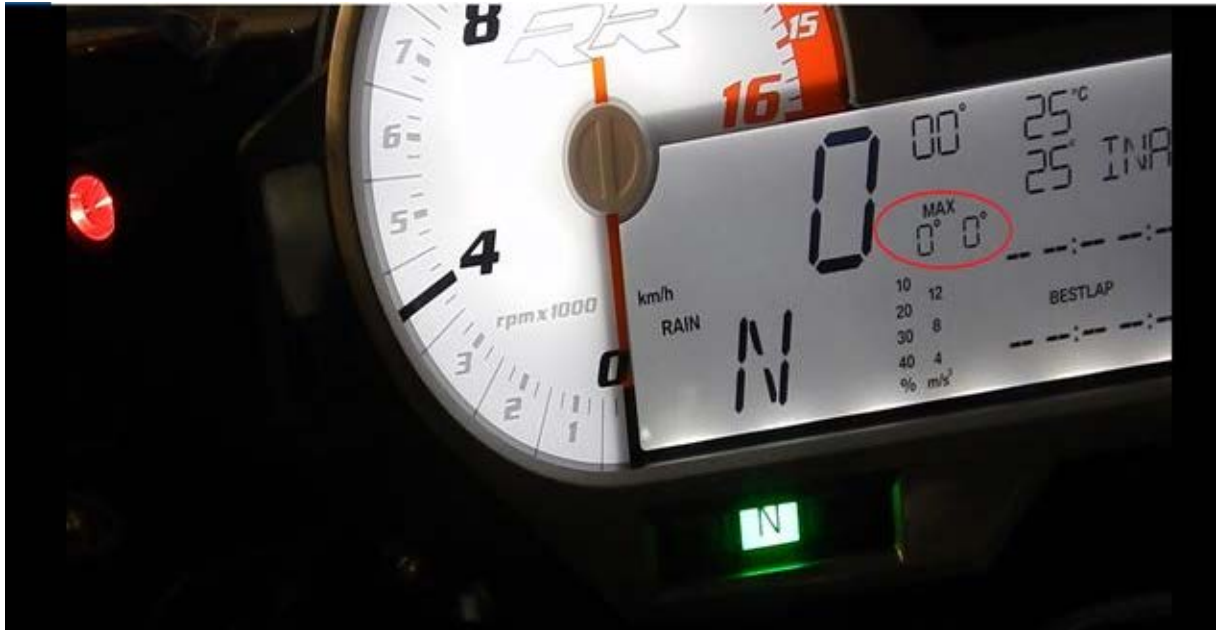
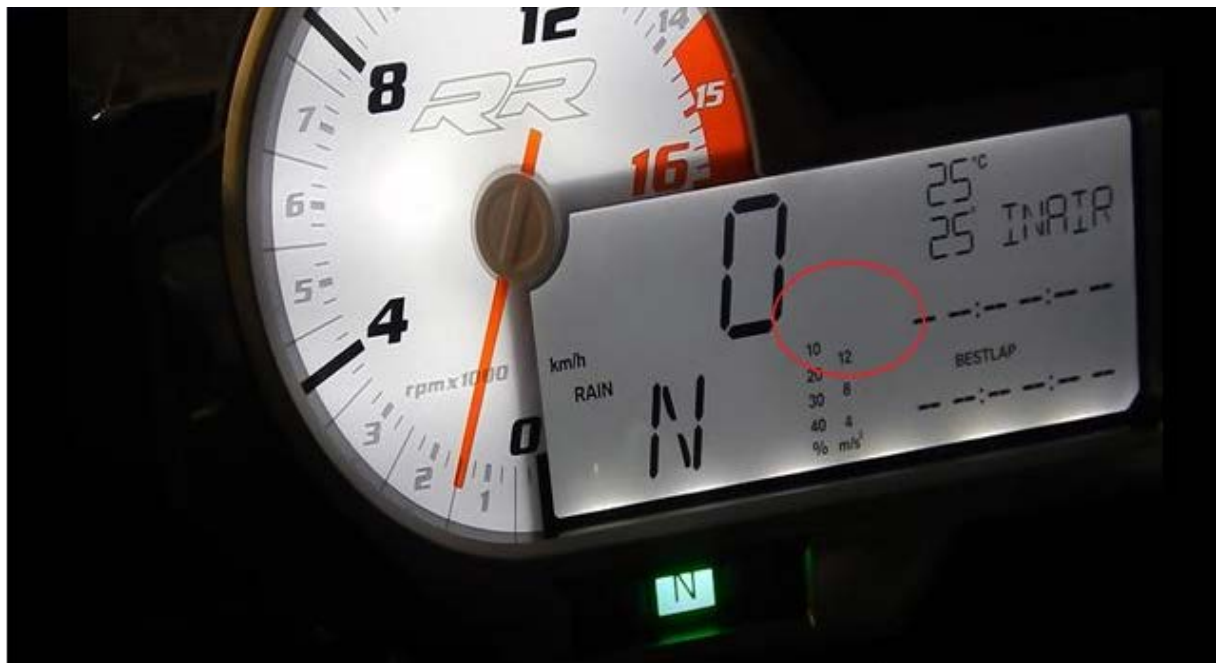
Occasionally the bank angle display is no longer visible in the instrument cluster after engine start. See attachment

Due to the voltage dip in an insufficiently charged battery at engine start, the angular rate sensor performs a reset.

At this time an invalid bank angle value is transmitted to the Instrument cluster.

The instrument cluster suppresses this invalid value and leaves the display blank

Charge battery.

K46/13 models: Update the software of the instrument cluster to I-level K001-17-03-500.

K46/12 models: Update the software of the instrument cluster to I-level K001-18-03-500
