Technical Service Bulletin

Subject: ALUMINUM WHEEL PAINT DAMAGE (BLACK SPOT, WHITE SPOT, FLAKING / PEELING, DISCOLORED, BLACKENED)	Bulletin No.: 02-003/18
	Last Issued: 02/13/2018

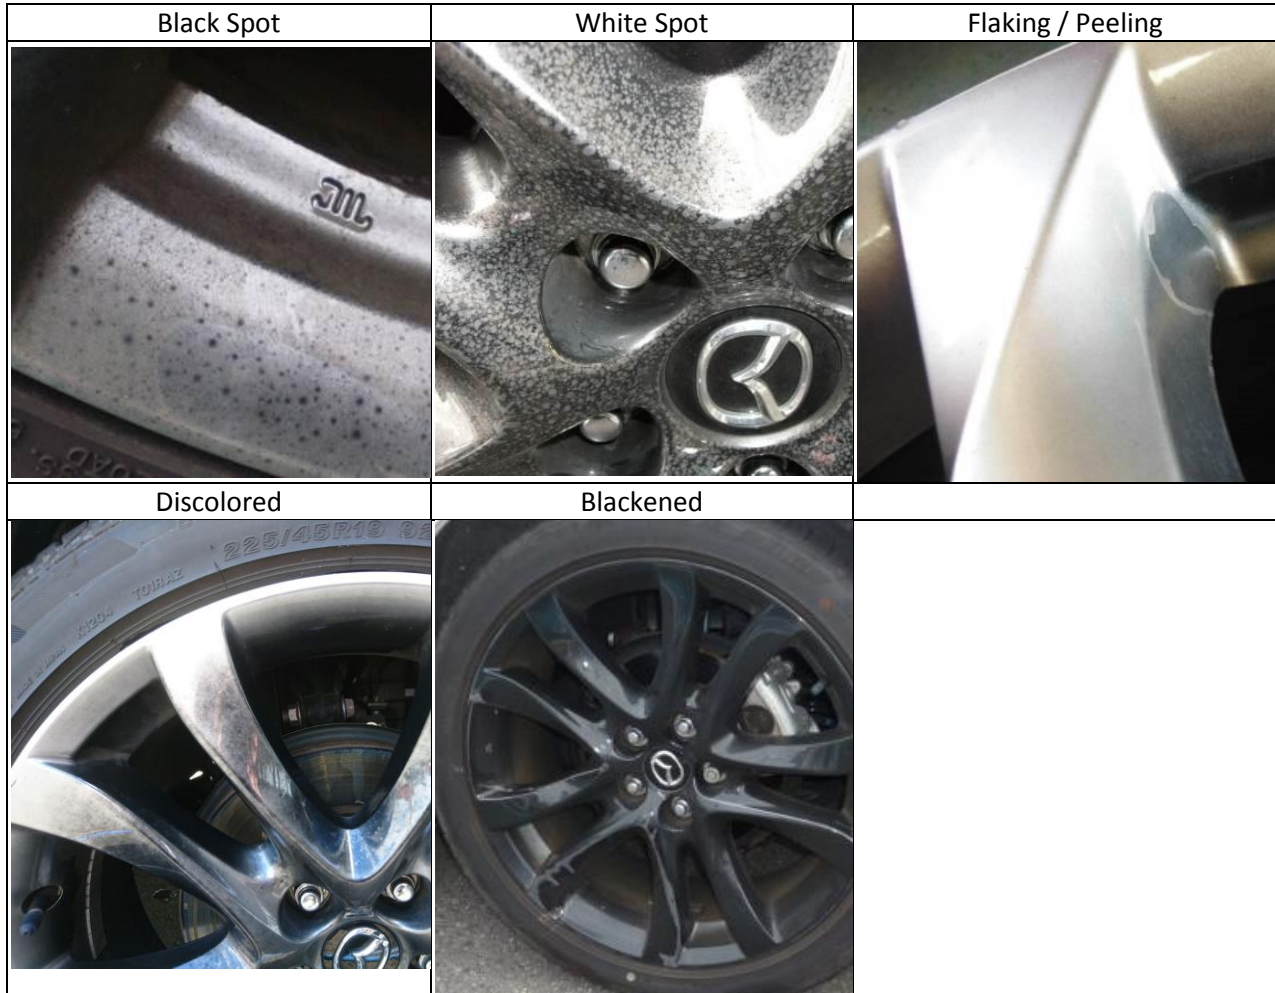
Some vehicles may exhibit an aluminum alloy type wheel(s) having one of the following paint damage conditions shown in the sample photos below. The damage extends to the front surface of the aluminum wheel partly or entirely.

1. Verify customer concern.
2. Is the aluminum alloy type wheel concern caused by an outside influence?
 - No - Go to step 3.
 - Yes - This service bulletin does not apply.
3. Replace the affected aluminum wheel(s). Refer to MGSS online Workshop Manual WHEEL BALANCE ADJUSTMENT (ALUMINUM ALLOY WHEEL).
4. Verify repair.
