# Technical Service Bulletin

MAZDA SERVICE PROGRAM (MSP49) - CREAKING / SQUEAKING NOISE FROM RIGHT REAR SUSPENSION Last Issued: 02/14/2018

Bulletin No.: 02-004/18	Last Issued: 02/14/2018

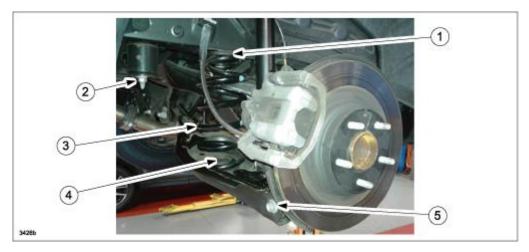
### **RIGHT REAR COIL SPRING REMOVAL/INSTALLATION**

1	Upper spring seat rubber
2	Rear stabilizer control link lower side nut - 45-55 {4.6-5.6, 34-40}**
3	Rear coil spring
4	Lower spring seat rubber
5	Rear lower arm outer bolt - 127-154 {13-15, 94-113}**
