SI B13 01 18  
Fuel Supply Systems

## SERVICE ACTION: CHECK ROUTING OF FUEL LINE

G01 (X3 xDrive 30iA)	G01 (X3 M40iA)		
----------------------	----------------	--	--

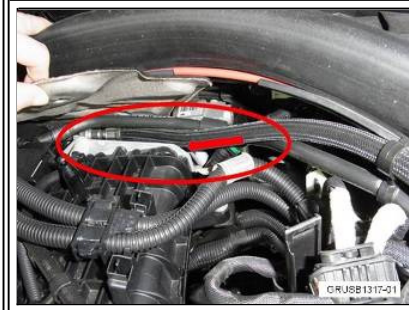
The fuel feed line is not correctly routed behind the tank ventilation line and may conflict with components of the intake system.

Picture shows incorrectly positioned fuel line (covered in a protective fabric), in front of the tank ventilation line, contacting the rear bracket of the intake manifold.

This may cause abrasion on the protective fabric coating of the fuel feed line.

Verify the proper routing of the fuel feed line as shown in the accompanying graphic.

1. Remove the engine acoustic cover. Identify the fuel feed line (covered in protective fabric) and the tank ventilation line (not covered in protective fabric).
2. If necessary, move the fuel feed line so that it is routed behind (slide underneath) the tank ventilation line and is not able to contact the components of the intake system.

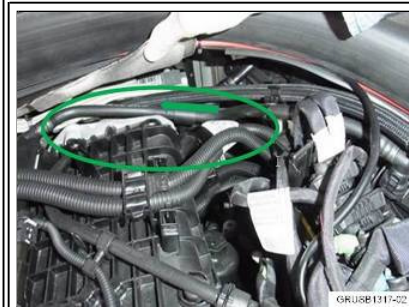
Proper location of the fuel line (behind the tank ventilation hose).
