DIAGNOSING NOISE FROM THE REAR EXHAUST FLAP (B58)

F22 (2 Series Coupe)	F23 (2 Series Convertible)	F30 (3 Series Sedan)	F32 (4 Series Coupe)
F33 (4 Series Convertible)	F34 (3 Series Gran Turismo)	F36 (4 Series Gran Coupe)

With the B58 engine.

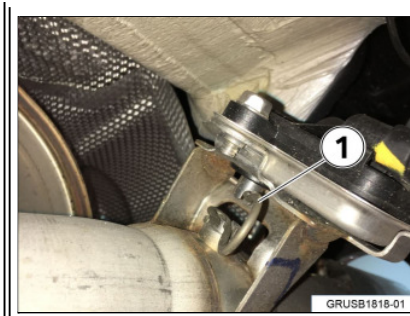
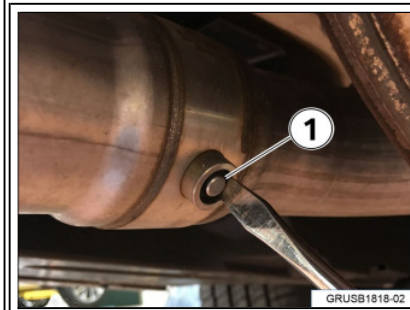
1. DME software application error (I-level is lower than F020-17-11-540) may cause the flap to stay in an undefined position which will cause it to rattle.
2. Loose or failed fixing bow (clip that connects the exhaust flap actuator to the exhaust flap)
3. Excessive play in the pivot bushing of the exhaust flap.

| | <ol style="list-style-type: none"> 2. If the fixing bow (1) is loose or damaged or missing – Replace the fixing bow. |
