SI B18 02 18  
Exhaust Systems

## EXHAUST TAILPIPES MISALIGNED (B57)

| G30 (540d xDrive) | | |

With the B57 diesel engine

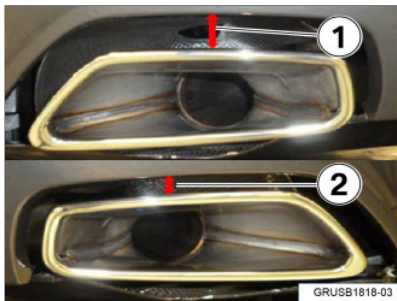
The rear tailpipe extensions do not line up evenly with the rear bumper.

The rear silencer is bent.

| | Confirm the tailpipes do not line up evenly with the bumper trim (1) and (2) and replace the rear silencer. |

Refer to Repair Instruction **18 10 031 Replacing the rear silencer**.
