SI B31 01 18  
Front Axle

March 2018  
Technical Service

## NOISE FROM FRONT AXLE WHEN STEERING

I01 (i3s & i3s REx)			
---------------------	--	--	--

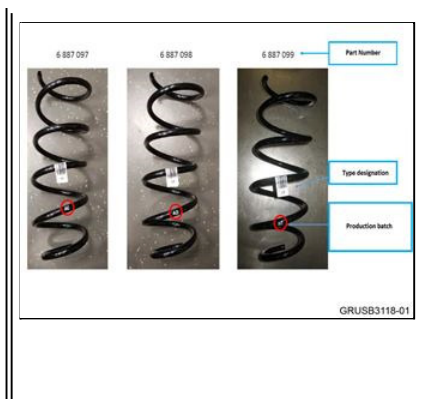
<p><a href="https://tinyurl.com/y9kwrucl">https://tinyurl.com/y9kwrucl</a></p>	<p>1. Attempt to reproduce the noise as indicated in the video.</p> <p><b>Was the noise produced under the conditions indicated in the Situation?</b></p> <p><b>YES-</b> go to next step.</p> <p><b>NO –</b> continue diagnosis with ISTA</p>
	<p>2. Before starting, check the production code of the replacement coil as shown.</p> <p><b>Is the coil spring marked with “AD”, “AE” or “AG” where indicated?</b></p>

**YES-** go to next step.

**NO** – obtain an acceptable replacement part with the proper code, then go to next step.

3. Install coil spring and spring pad/protective tube following repair instructions REP 31 33 100 – “Replace coil spring front left / right”.
4. Repeat procedure on opposite side of vehicle.
