SI B33 03 15
Rear Axle

March 2018
Technical Service

LEAKING REAR DIFFERENTIAL (QMVH)

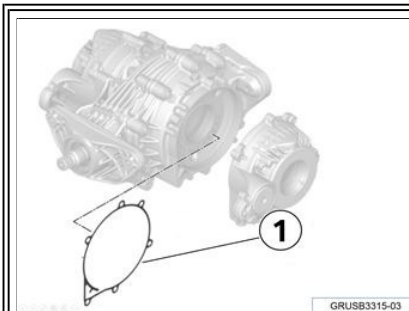
There is an oil leak from the rear differential housing.

The liquid-type sealer used between the main differential housing and the outer superimposing gear units has failed.

Gaskets are available through EPC (PN 33 10 7 601 264) for resealing the superimposing gear cases to the main differential housing (1)

Replace the gaskets between the superimposing gear cases and the main differential housing.
