## TAILGATE UNINTENTIONALLY OPENS

This Service Information bulletin supersedes SI B51 30 16 **dated January 2018**.

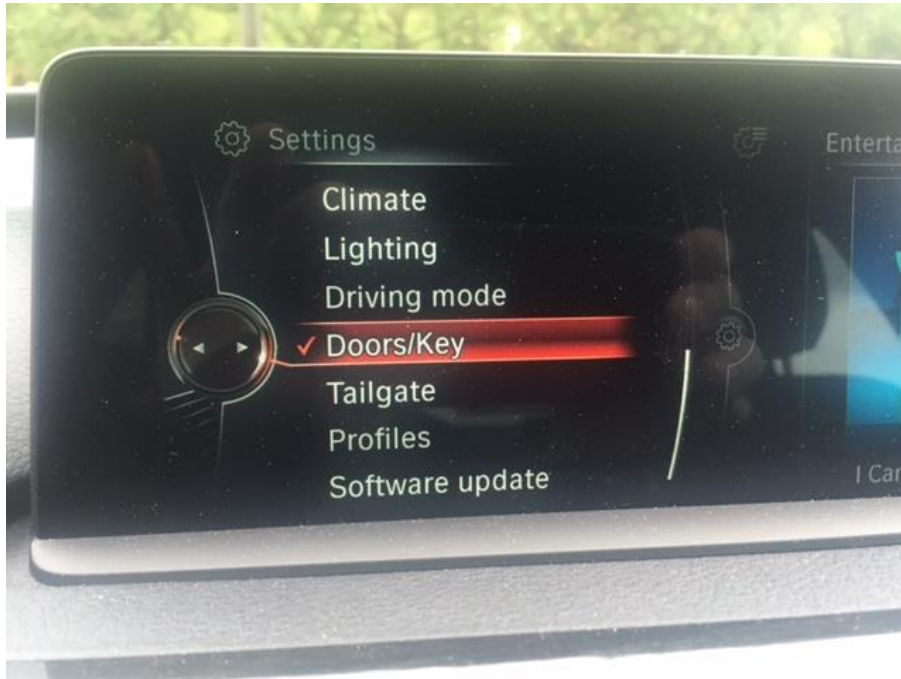
Under the Vehicle settings menu, select Doors/Key:

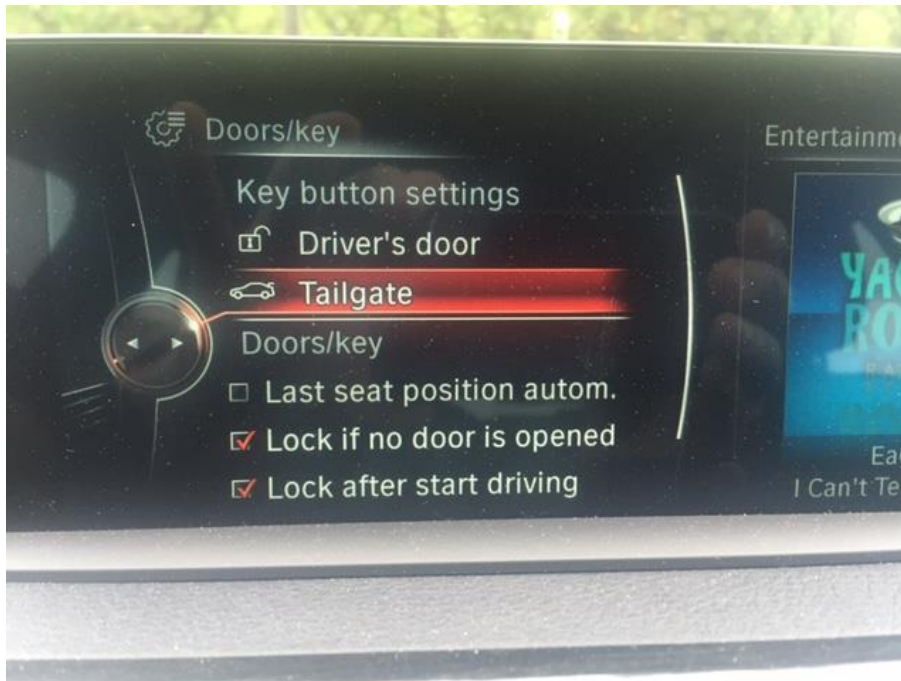
Then select Tailgate:

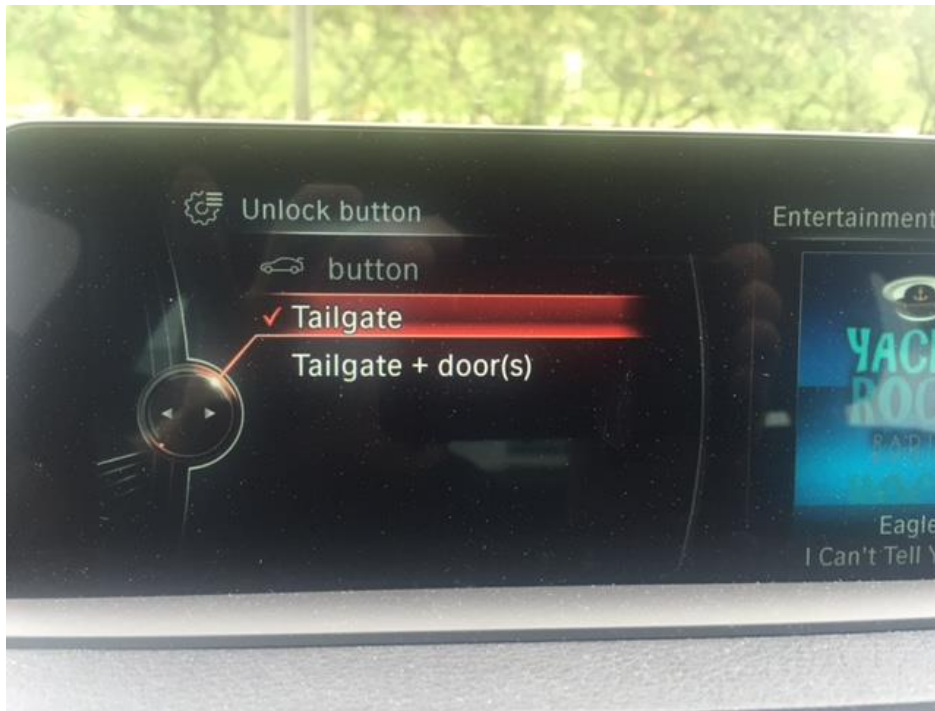
Ensure that Tailgate is checked off:
