SI B52 01 18
Seats

March 2018
Technical Service

EXPOSED FOAM IS VISIBLE UNDER THE FRONT SEAT

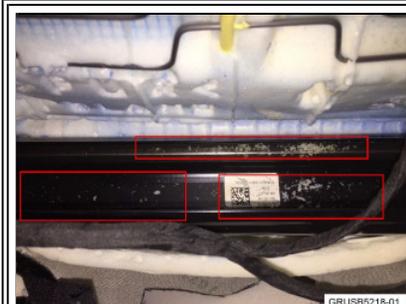
- Exposed foam is visible under the optional front sport seat or in rear footwell as shown in the picture.

Note: the seat position is all the way to the front.

Backrest foam, in the vicinity of the backrest adjustment lever, is deformed.

Replace backrest foam and reinforce with felt tape to prevent reoccurrence.
