SI B54 03 18
Special Roofs

PANORAMIC SUNROOF DOES NOT FUNCTION OR CAUSES NOISE DURING OPERATION

G01 (X3) produced from 9/11/2017-1/15/2018		
---	--	--

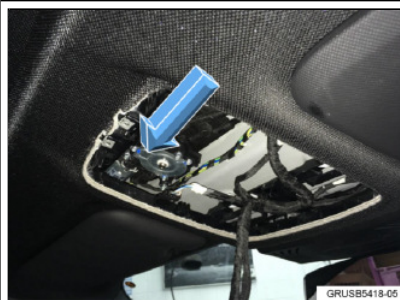
1. Remove the FZD to inspect the sunroof drive motor following repair instructions **REP 61 31 043** Removing and installing the **FZD**.

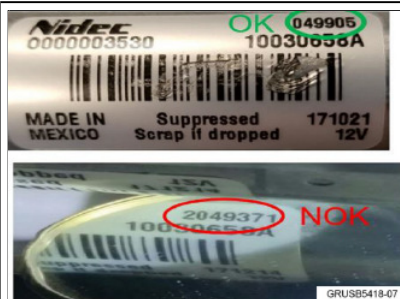
2. Inspect the identification label number on the sunroof drive motor. The identification number is located in the top right corner of the label as shown.

3. Does the number on the identification label contain **6 or 7**

<p>digits?</p> <p>6 digits: This bulletin does not apply, continue normal diagnosis of the panoramic sunroof.</p> <p>7 digits: Replace the sunroof drive motor, following repair instruction REP 67 61 580 Replacing the drive for the glass slide/tilt sunroof panel.</p>
--	---
