## High-Voltage Charging Cable Lock Malfunction

This Service Information bulletin supersedes SI B61 08 15 dated **March 2016**.

i3 (I01)

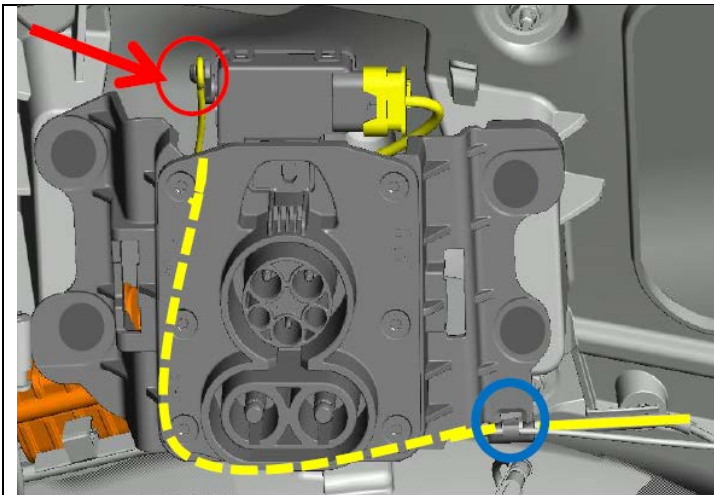
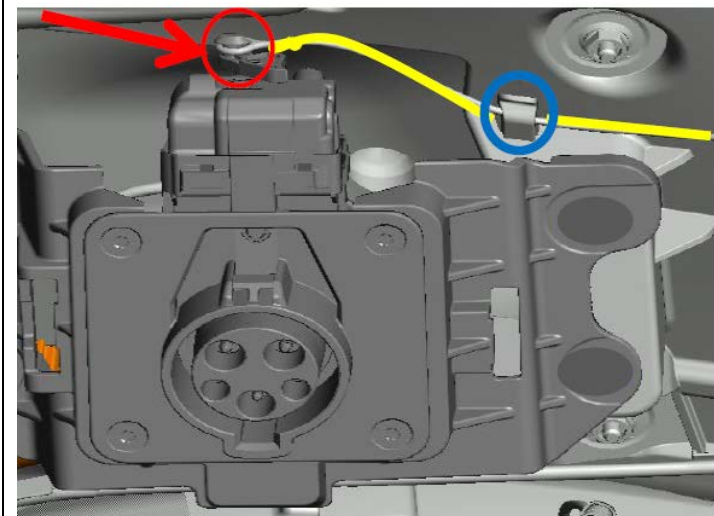
**PROCEDURE****LIM FAULT CODE 805532**

805532 "High-voltage charging socket: Lock on the charging plug, status implausible"

- The emergency-operation tensioning strap is jammed.
- The actuator drive for the charging socket is not working.

- Detach the tensioning strap from the actuator drive (indicated by the red arrow).
- Ensure that the tensioning strap can move freely in the guides (marked in blue). The tensioning strap must not be tensioned or under pressure.
- Position and secure the tension strap as needed.

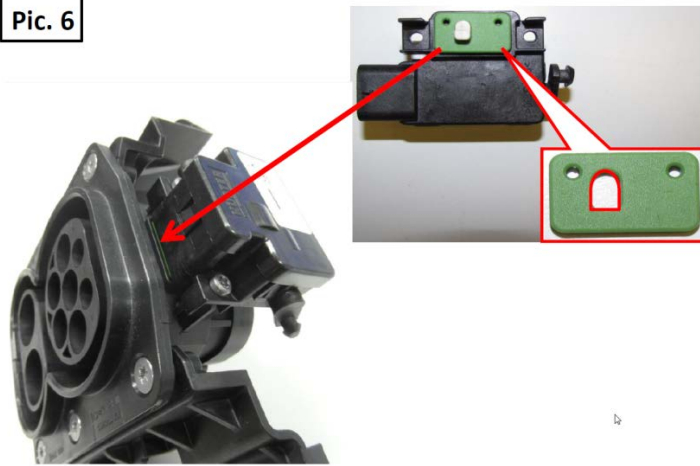
Pic. 6

805503 "High-voltage charging socket: Charging plug lock, line disconnection"

- Check the wiring at the actuator for any damage and repair, as needed.
- If the wiring is OK, replace the actuator drive for the charging cable lock.
- Refer to ISTA Repair Instruction 67 11 595, "Remove and replace the actuator drive for the high-voltage charging cable."
- Check that the green seal is installed correctly as shown.
