SI B63 05 16  
Lights

## HEADLIGHT ASSEMBLIES HAVE VISIBLE INTERNAL MOISTURE/CONDENSATION

This Service Information bulletin supersedes SI B63 05 16 dated **November 2016**

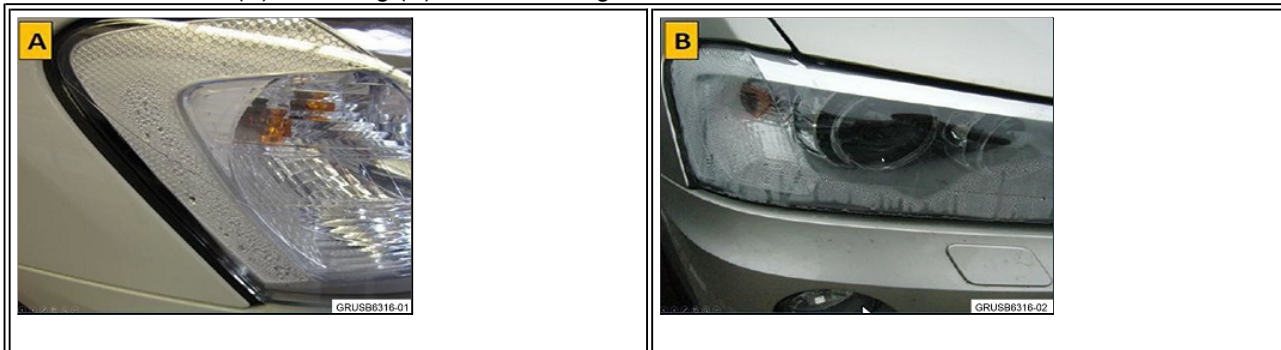
Water on the inside (A) or misting (B) of both headlight lenses that is visible from outside.

Water inside the headlights can be caused by two situations:

- Water/moisture ingress into the headlight housing.
- Thermal conditions that result in the formation of condensation.

**Note: An important indication that the moisture issue is caused by “condensation” rather than a “water leak” into the headlight housing, there will be misting/condensation in “both headlights.”**

- Dry out both headlights.
- **Only** if there is a permanent stain then replace the affected headlight.

- Connect the battery charger to the vehicle. Always connect a BMW approved battery charger / power supply (SI B04 23 10).
- Open all accessible service covers that can be reached with headlights still installed.
- Turn on the high beam, until the condensation has cleared completely.
- This procedure will take about 30 min to dry both headlights.

- Remove both headlights follow ISTA repair procedure.
- Open all service covers.
- Using a hot air blower, dry out the headlight (to prevent damage to the headlight, the temperature must not exceed 80°C / 176 °F)

3. After the drying has been completed:
  - Check that the headlight functions correctly.
  - Check for dried water stains (for example, lime scale or dirty edges).

4. Reassemble the light cover and attachment parts on the headlight ensuring the following:
  - The seals are firmly seated.
  - The rubber grommets are seated correctly on the ventilation openings.
5. Reinstall the headlight in accordance with Repair Instructions.
