Subject: MAZDA CONNECT REBOOTS OR SCREEN TURNS BLACK DURING EXTREMELY COLD TEMPERATURES	Bulletin No.: 09-001/18
	Last Issued: 02/22/2018

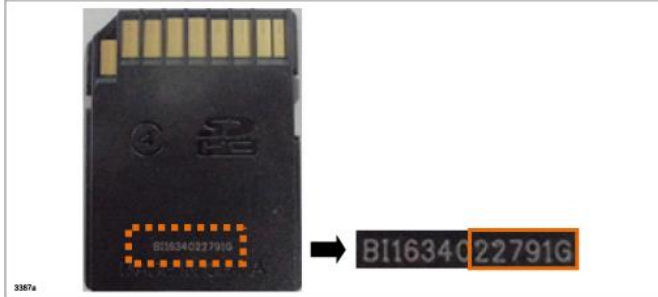
1. Verify customer concern.
2. Remove the SD card and check the last 6 digits of the lot number on the SD card.

- If the SD card has any of the following 6 digit lot numbers, replace it with a new SD card.

50424D	50631D	50635G	50881G	50955G
50428G	50632G	50877D	50913D	50995G
