Technical Service Bulletin

RUST / PAINT BLISTER ON FRONT SIDE SILL

Bulletin No.: 09-006/18

2014-2018 Mazda3

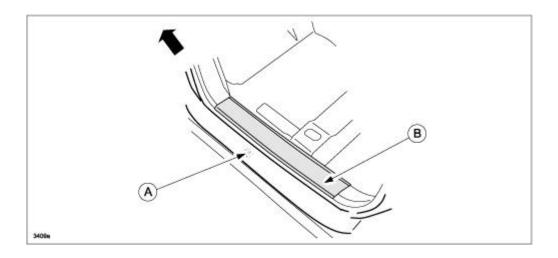
Some vehicles may exhibit rust/paint blisters (1) on the surface of the front side sill near the the scuff plates (2). This is likely caused by the driver's or passenger's shoe(s) contacting the side sill when stepping in and/or out of the vehicle since the side sill of the Mazda3 is wider than other models. When this happens, mud/sand stuck to the sole of the shoe scratches the paint surface, which then develops into rust/paint blisters.

When you receive a customer complaint on this concern, use the following repair procedure.
