SIL 10-TC10-18  
April, 2018  
Page 1 of 2

**SUBJECT:** TC10® Internal Wiring Harness Speed Sensor Connector Color Change

**MODELS AFFECTED:** TC10® Product Family Transmissions

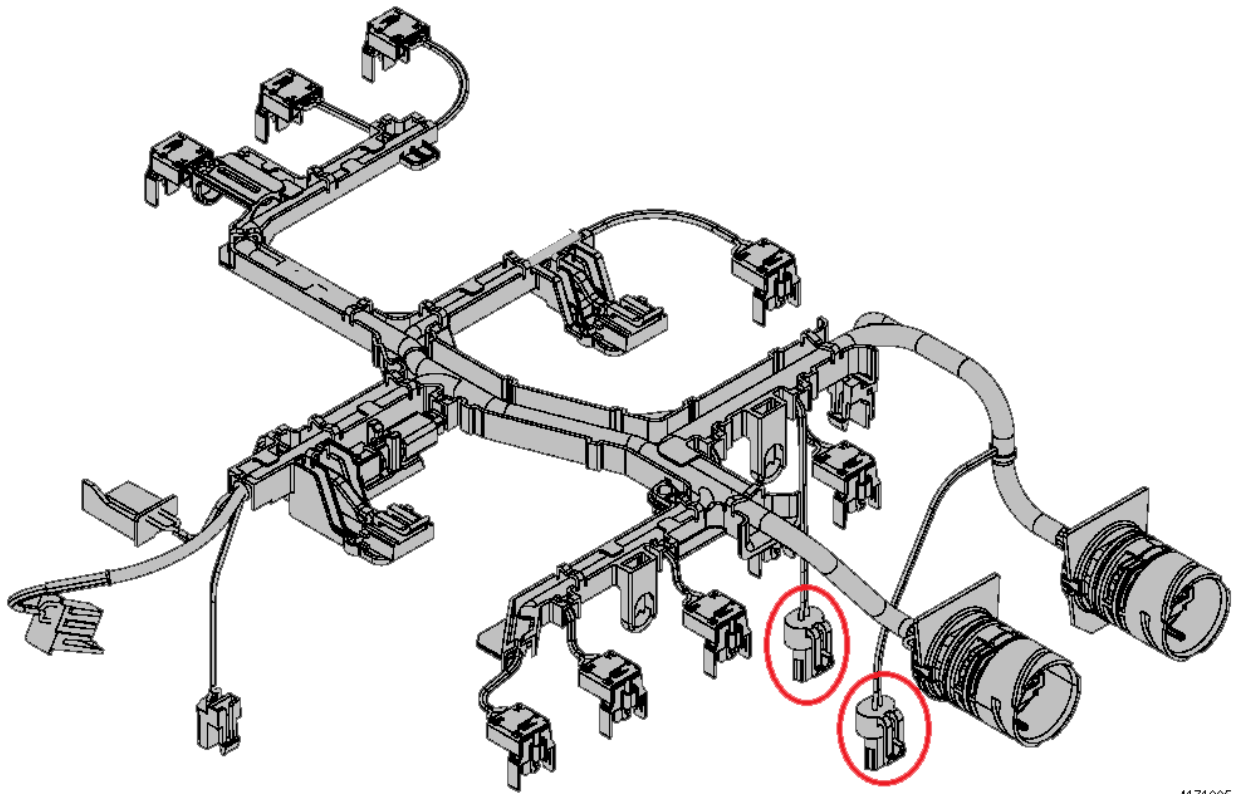
**Figure 1. Internal Wiring Harness Speed Sensor Connector Locations**

The two black speed sensor connectors on the internal wiring harness will be changed to gray (refer to [Figure 1](#)). There will be no P/N change to the existing internal wiring harness (P/N 29554690).
