GROUP <b>BOD</b>	MODEL <b>2018MY Stinger (CK)</b>
	NUMBER <b>184</b>	DATE <b>April 2018</b>
<b>TECHNICAL SERVICE BULLETIN</b>		
<b>SUBJECT: SERVICE ACTION: REAR HATCH RATTLE REPAIR BY STRIKER ADJUSTMENT (SA347)</b>

This bulletin provides the procedure to inspect and/or adjust the rear hatch striker on some 2018MY Stinger (CK) vehicles, produced from September 21, 2017 through December 18, 2017, which may exhibit a rattle noise while driving, especially over bumps. Follow the procedure outlined in this bulletin to adjust the rear hatch striker\*. Before conducting the procedure, verify that the vehicle is included in the list of affected VINs.

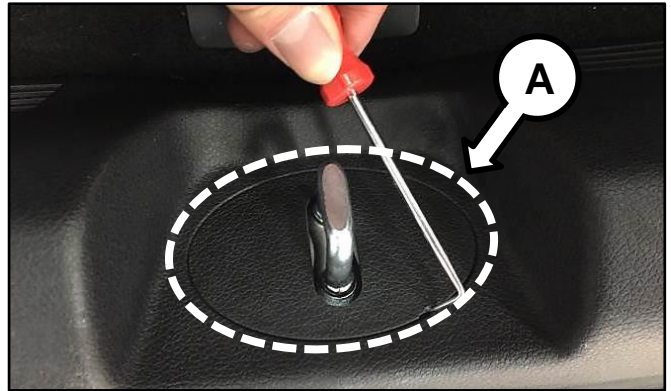
1. Carefully remove the striker cover (A) using a small pick tool.

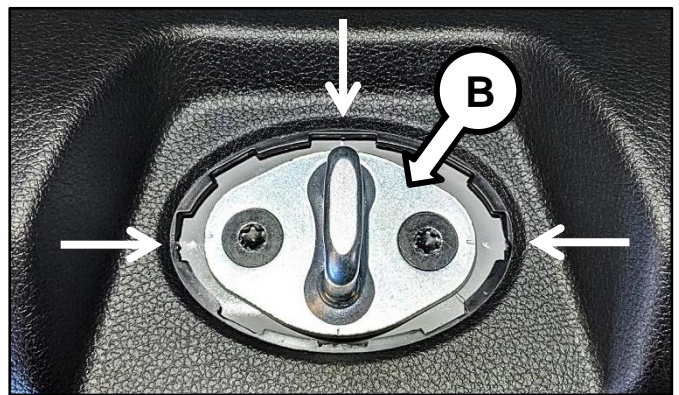
2. Inspect the alignment marks on both the body and the striker (B). The markers must be aligned to match. If so, reinstall the striker cover to complete the inspection. Road test vehicle on rough road to confirm no rattle noise is present.

If striker marks are not aligned, proceed to the next step to adjust.

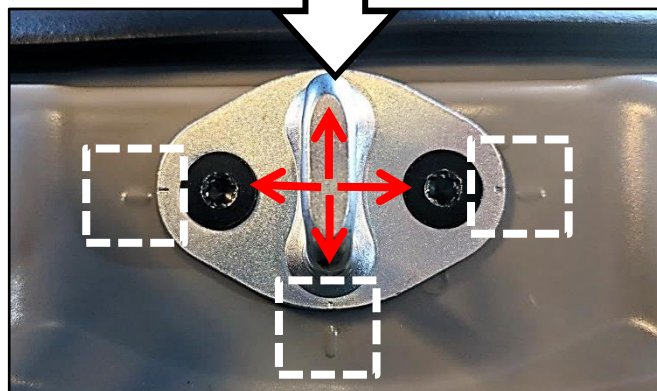
- Alignment marks for reference. Striker may be moved in any direction.
