Technical Service Bulletin: TSB180046	Released Date: 16-Apr-2018
Broken Aftertreatment DOC Baffle

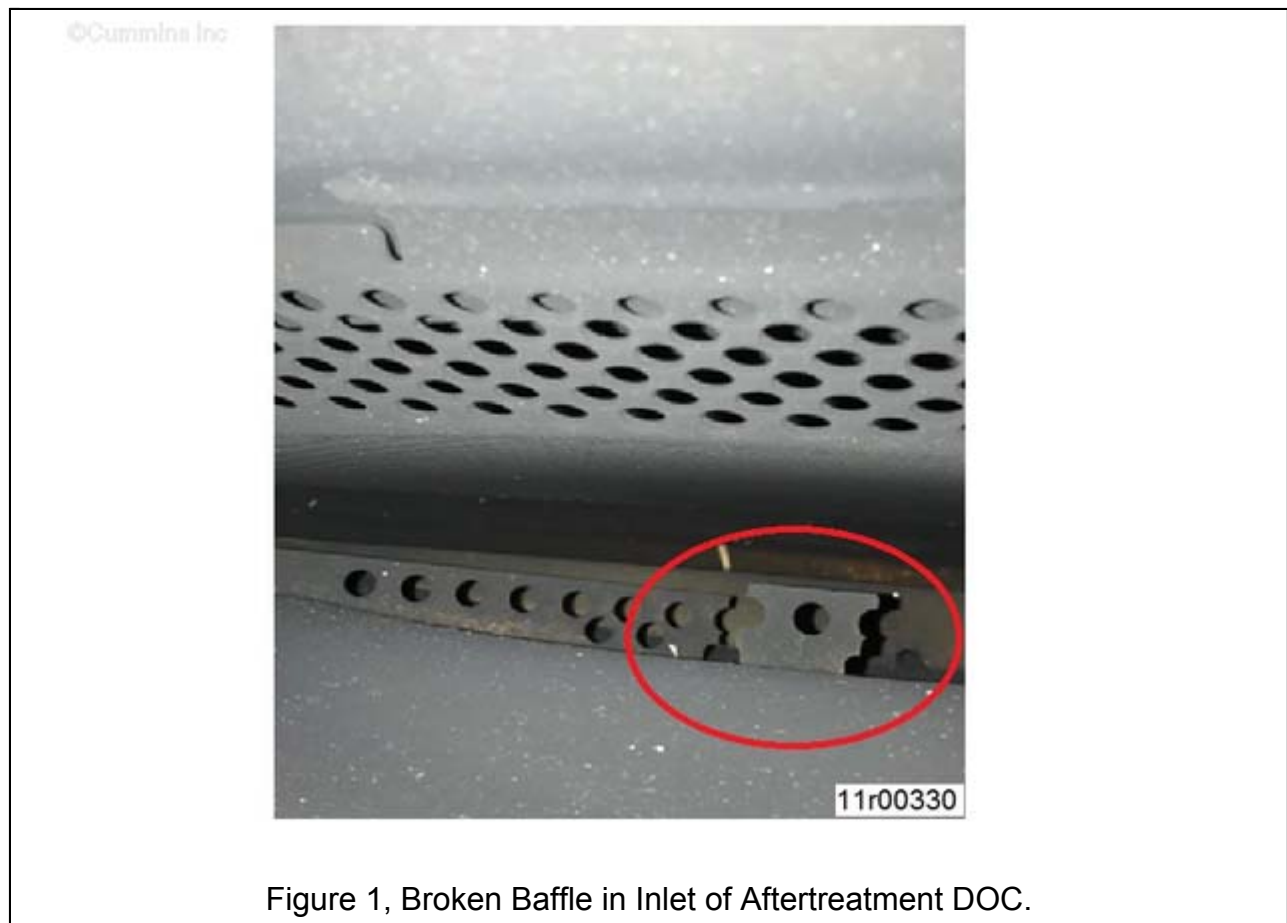
- Welding issues have been found inside inlet tube of aftertreatment DOC causing baffle breakage.
- See Figures 1 and 2 for examples of broken aftertreatment DOC baffles.

If broken baffle is found in inlet aftertreatment DOC; replace aftertreatment DOC.

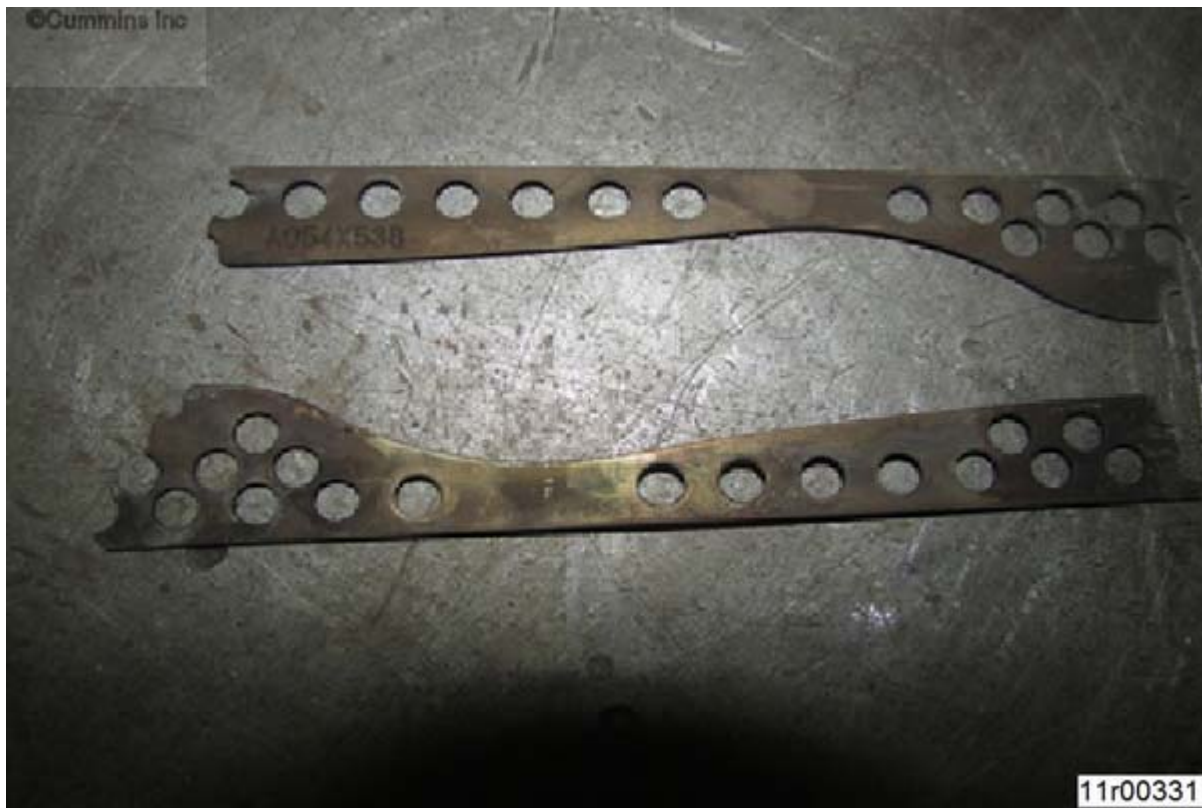
Figure 2, Broken Aftertreatment DOC Baffle.
