## TECHNICAL SERVICE BULLETIN

### Hands-free Liftgate - Liftgate Opens/Closes When Contacting Rear Bumper With Key Present - Built On Or Before 15-Dec-2017

**18-2055**

<b>Ford</b> 2015-2017 Edge
<b>Lincoln</b> 2016-2018 MKX

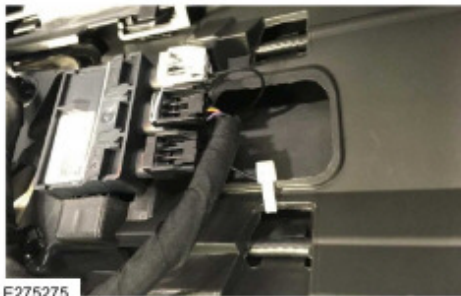
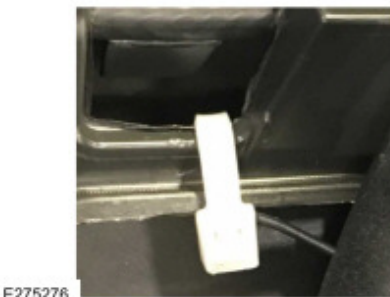
**Issue:** Some 2015-2017 Edge vehicles built on or before 10-Aug-2017 and 2016-2018 MKX vehicles built on or before 15-Dec-2017, equipped with a power liftgate and the hands-free liftgate activation feature may exhibit the liftgate opening or closing when a rear door is slammed shut, or the rear fascia is contacted such as kneeling or resting a foot on the fascia while the key is present.

3. Separate the hands-free liftgate actuation sensor lead wires and carefully secure with tie strap. The tie straps should be loose enough to prevent excessive pulling and damage or chafing to the lead wires. (Figures 1 - 2)
