TECHNICAL SERVICE BULLETIN

2.0L GDI - Various Drivability Concerns And/Or Illuminated Malfunction Indicator Lamp (MIL)

18-2062

Ford 2012-2014 Focus

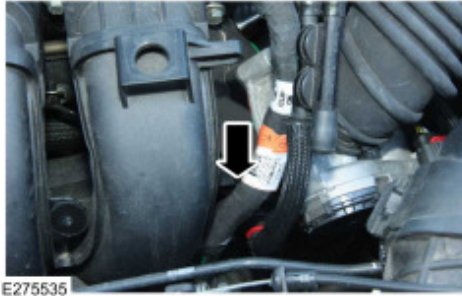
Figure 1

2. Visually inspect the engine harness for chafing against the intake manifold, near the throttle body. It may be necessary to use a small mirror to inspect the back side of the harness where the harness may contact the intake manifold. Is a harness chafe condition present? (Figure 1)

3. Remove the harness protection and repair any damaged circuits. Refer to Cell 5 in the Wiring Diagram.
