2017MY
Niro (DE HEV)

PS553

HEV WARNING LIGHT AND DTC P1B25/P1B77

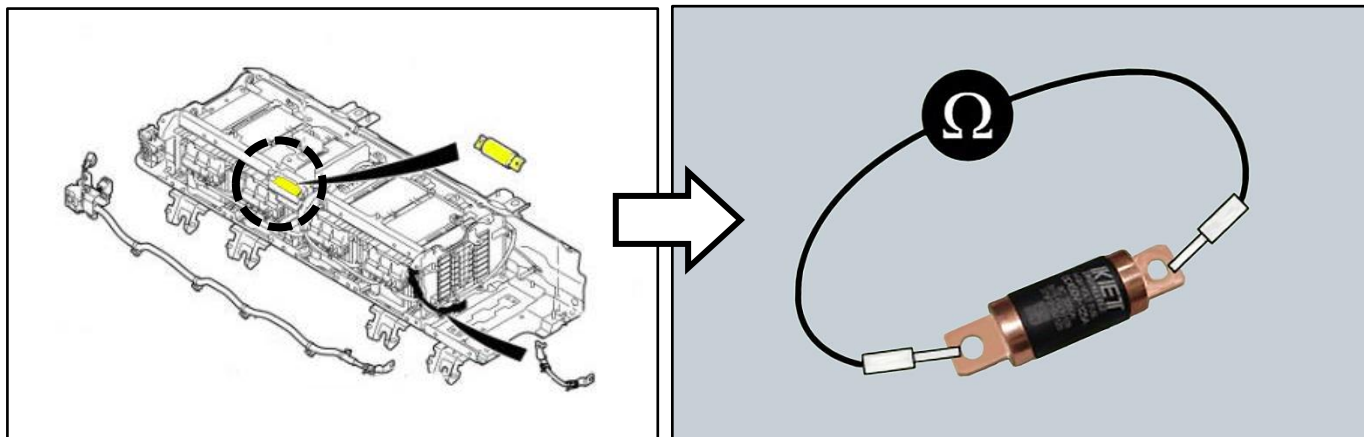
Hi-Voltage Battery Fuse

When addressing a concern related to the Niro HV warning light ON, and KDS detects a primary DTC P1B25 (HV Path Fault) and secondary DTC P1B77 (HV Pre-Charge Fault), then the 125 Amp High Voltage Battery Fuse should be inspected for an intermittent and/or an open condition.

Measure the resistance while tapping on the fuse (less than $<1\Omega$ resistance).

Specification: 1Ω or less (68°F)

If the measured resistance is not within specification, or the P1B25 DTC is intermittent, replace the 125 Amp main HV battery fuse with the newer 170 Amp main HV battery fuse.
(Refer to EPC 37-371)
