**** TECHNICAL INFORMATION NOTICE ****

DATE: April 12, 2018
TO: Mitsubishi Motors US & Puerto Rico Dealer Service and Parts Managers
RE: DAS Software Update for Rear View Camera Freezing Issue
TIN NO. TIN-18-54-003

AFFECTED VEHICLES: 2017 Lancer Limited Edition, Mirage, Mirage G4, Outlander Sport Limited Edition

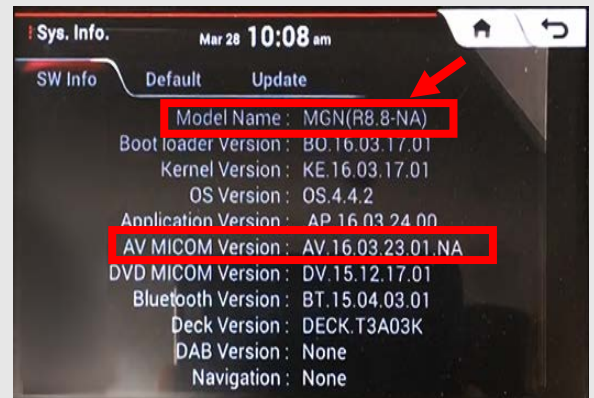
Example of Older Version

The software needs to be updated if the numerical value is **prior** to the Model Name and AV MICOM versions below:

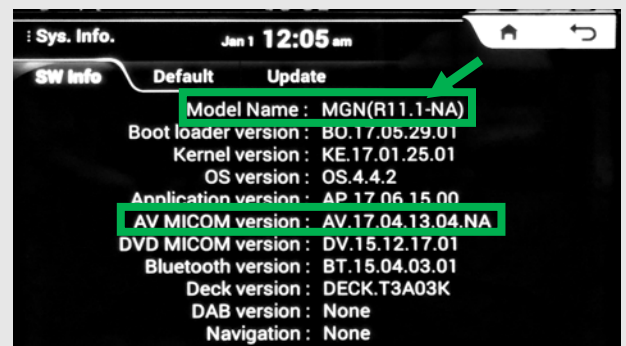
Example of Updated Version

Model Name: MGN(R11.1-NA)
AV Micom Version: AV.17.04.13.04.NA

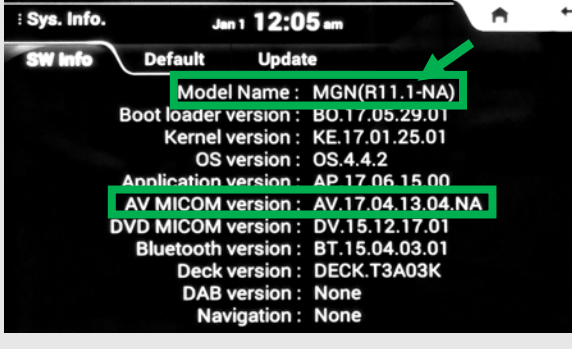
<p>28. Check the software version. It should be Model name and AV Micom Version shown below.</p> <p>Model Name: MGN(R11.1-NA) AV MICOM Version: AV.17.04.13.04.NA</p>
