# Technical Service Bulletin

SUBJECT: <b>SEAT BELT FRAYED FROM BEING CAUGHT UNDER SEAT RECLINING ADJUSTING LEVER</b>			No: <b>TSB-18-52A-001</b>
			DATE: <b>April 2018</b>
			MODEL: <b>See below</b>
CIRCULATE TO:	<input type="checkbox"/> GENERAL MANAGER	<input checked="" type="checkbox"/> PARTS MANAGER	<input checked="" type="checkbox"/> TECHNICIAN
<input checked="" type="checkbox"/> SERVICE ADVISOR	<input checked="" type="checkbox"/> SERVICE MANAGER	<input checked="" type="checkbox"/> WARRANTY PROCESSOR	<input type="checkbox"/> SALES MANAGER

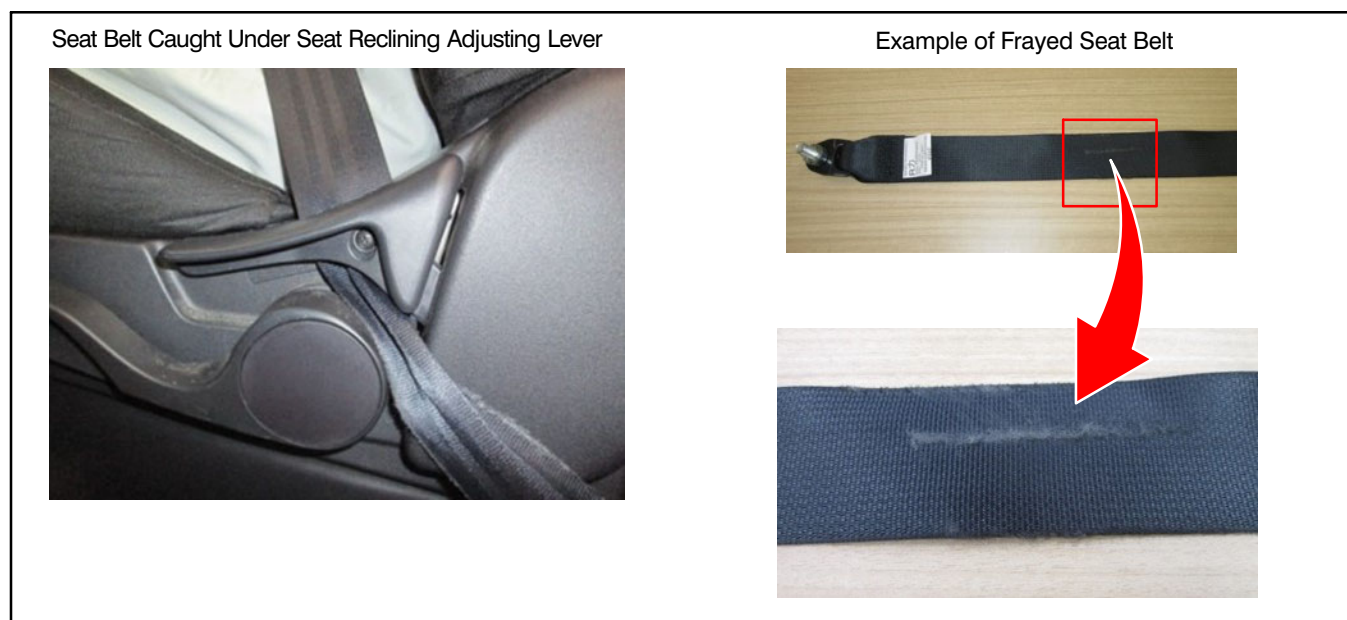
A customer may report the front seat belt fraying as a result of being caught under the seat reclining adjusting lever. If the adjusting lever or the seat back is operated while the seat belt is caught under the reclining adjusting lever, the seat belt can be rubbed by the edge of the reclining adjusting lever or the tip of the tapping screw, resulting in a frayed seat belt.

The shape of the seat reclining adjusting lever has been modified to prevent fraying of the seat belt should it get caught under the lever.

This TSB instructs dealers how to replace the front seat belt and reclining adjusting lever (driver and/or passenger side) with a countermeasure part on affected vehicles.

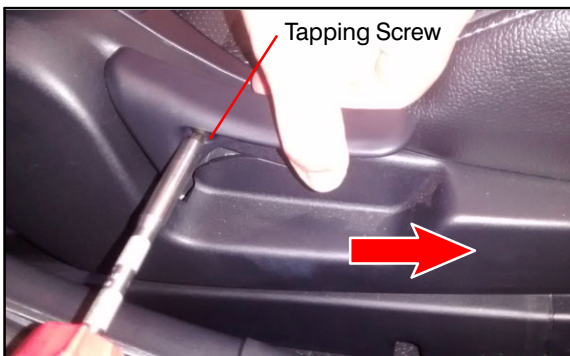
**NOTE:** The new part has an extended flange. This design ensures the seat belt will not rub against the edge of the lever or the tip of the tapping screw.

2. Confirm the replacement seat reclining adjusting lever is the new countermeasure part.
