LTB00557NAS5

TECHNICAL BULLETIN

204-06: Ride and Handling Optimization

'Knock' Sound From Front Suspension

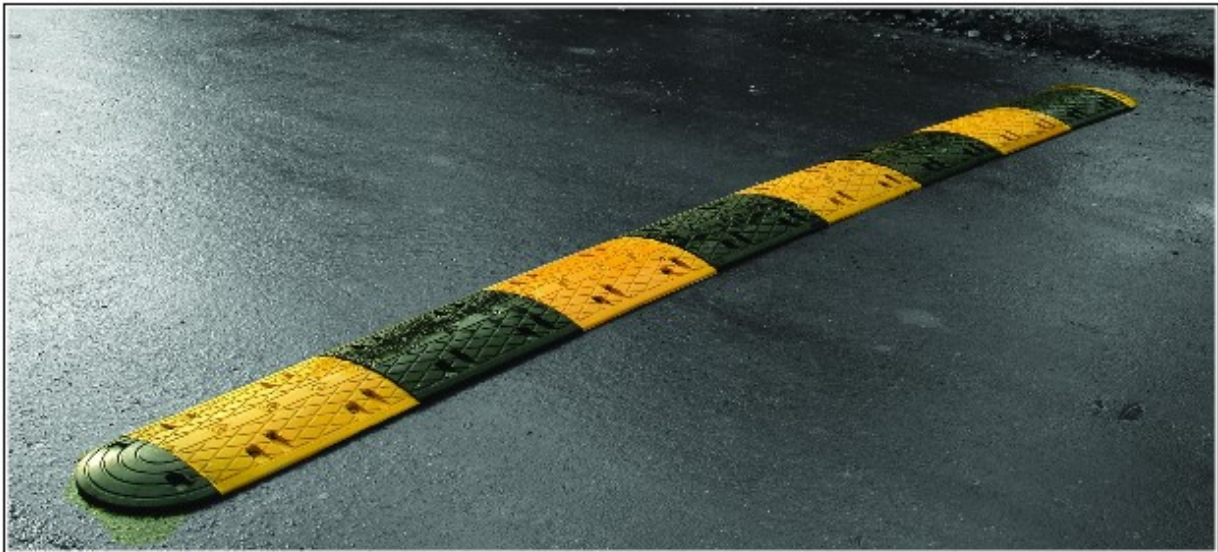
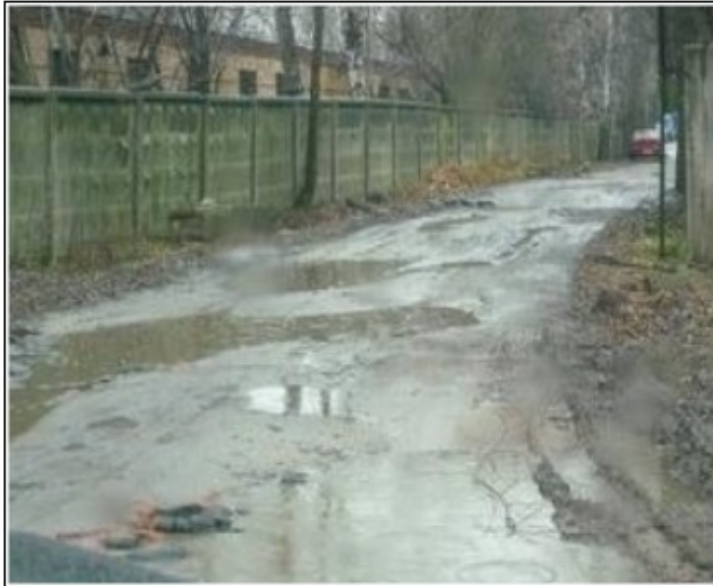
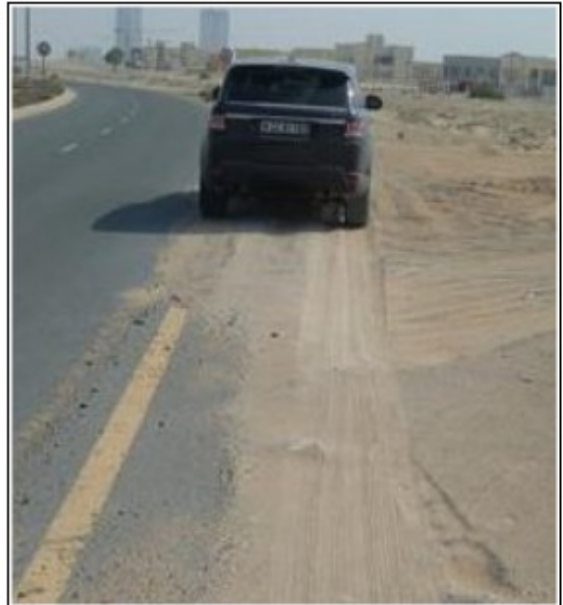
E162272

SYMPTOM: single 'knock' OR a series of isolated 'knocks':

- **Drive Cycle / Conditions:** single-wheel and dual-wheel inputs from speed bumps /damaged road surfaces or similar while traveling ONLY forward at speeds of up to 25mph (40kmh).
 - **Action:** perform the SERVICE INSTRUCTION listed below.

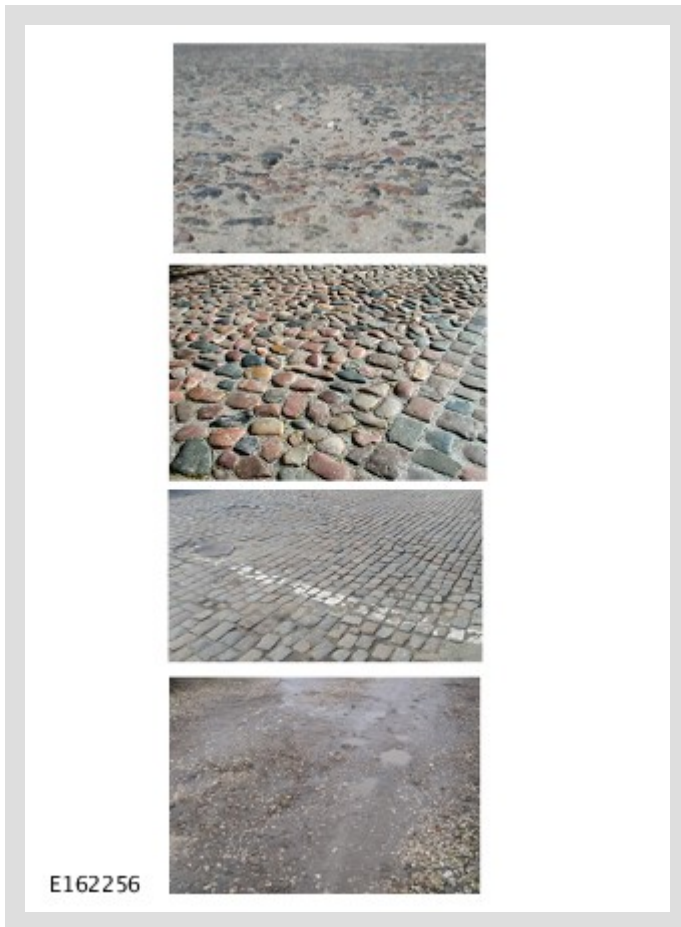
SYMPTOM: 'rattle' noise:

- **Drive Cycle / Conditions:** noise occurs while traveling at speeds up to 20mph (32kmh) over road surfaces shown.
 - **Action:** refer to Technical Bulletin LTB00618NAS, 'Click' / 'Rattle' Noise From Engine Compartment When Driving.

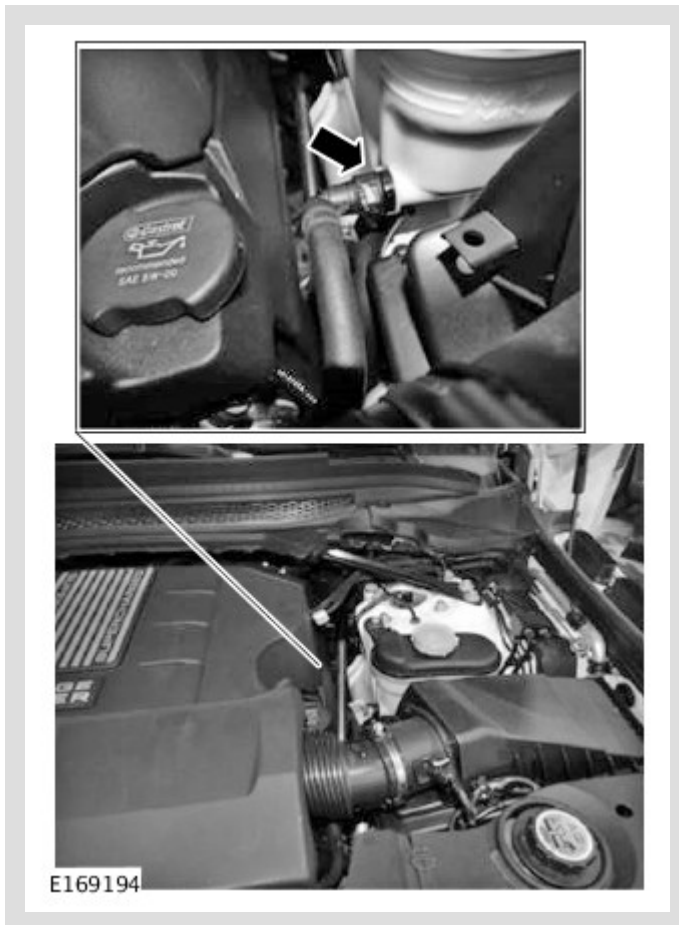
Check the Dynamic Response system fluid reservoir for leaks:

- If a leak is not present, go to the next Step.
- If a leak is present, replace the Dynamic Response system fluid reservoir (see TOPIx Workshop Manual section 204-06: Ride and handling optimization - Removal and installation - Fluid reservoir).

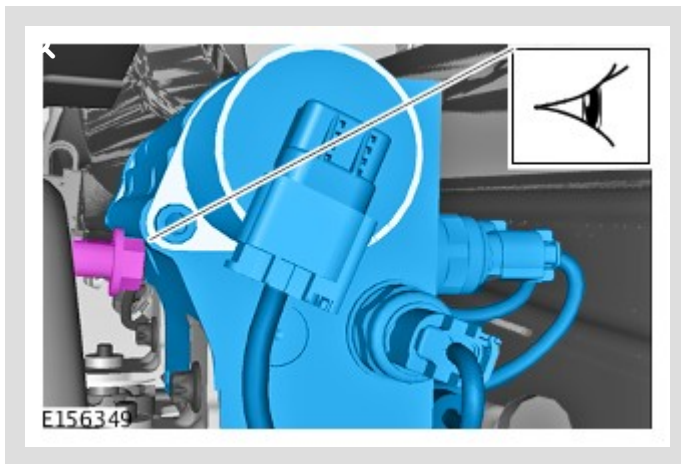
View of the end of hydraulic valve block from front of vehicle.

Check the valve block to body stud clearance.

- If there is sufficient clearance between the valve block body and the plastic body fastener that secures the fuel lines, go to Step 8.
- If there is not sufficient clearance between the valve block body and the plastic body fastener that secures the fuel lines, go to Step 7.

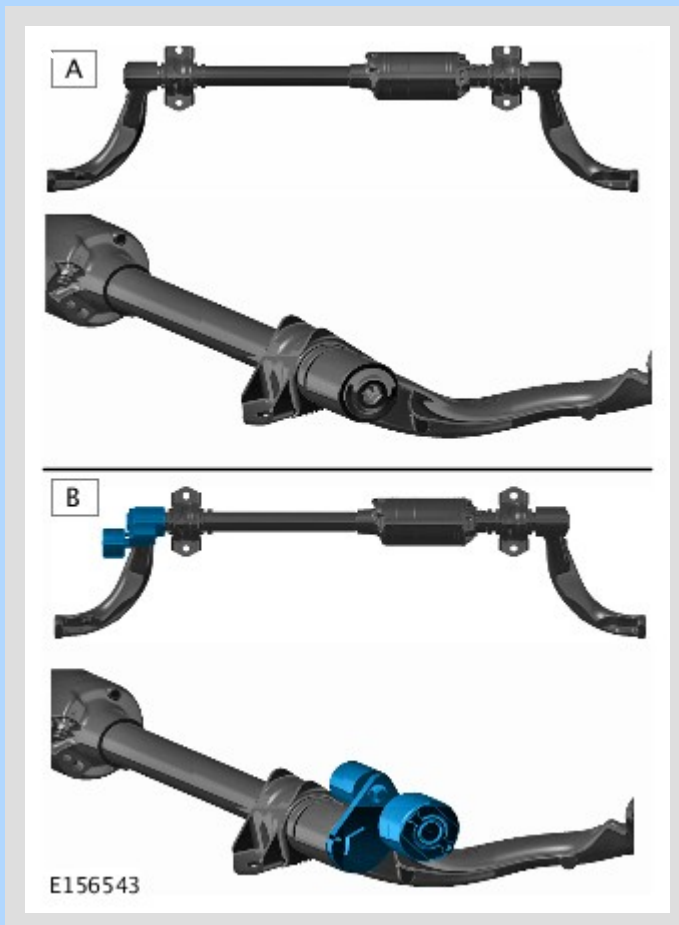
If the latest specification of front actuator bar is fitted, only replace it if it is damaged/leaking fluid.

After performing all listed remedial actions, it is possible that a low level of residual knocking noise may still be present. This low level of knocking noise may be caused by the Dynamic Response system's hydraulic operation. If the concern has not improved to an acceptable level, go to the next Step.

2013MY Range Rover (L405) vehicles up to VIN 125193 only: if the knocking noise is still present and considered unacceptable after performing above steps, replace the Dynamic Response front actuator with part number LR052058 **(B)** (see TOPIx Workshop Manual section 204-06: Ride and Handling Optimisation - Front Stabilizer Bar).

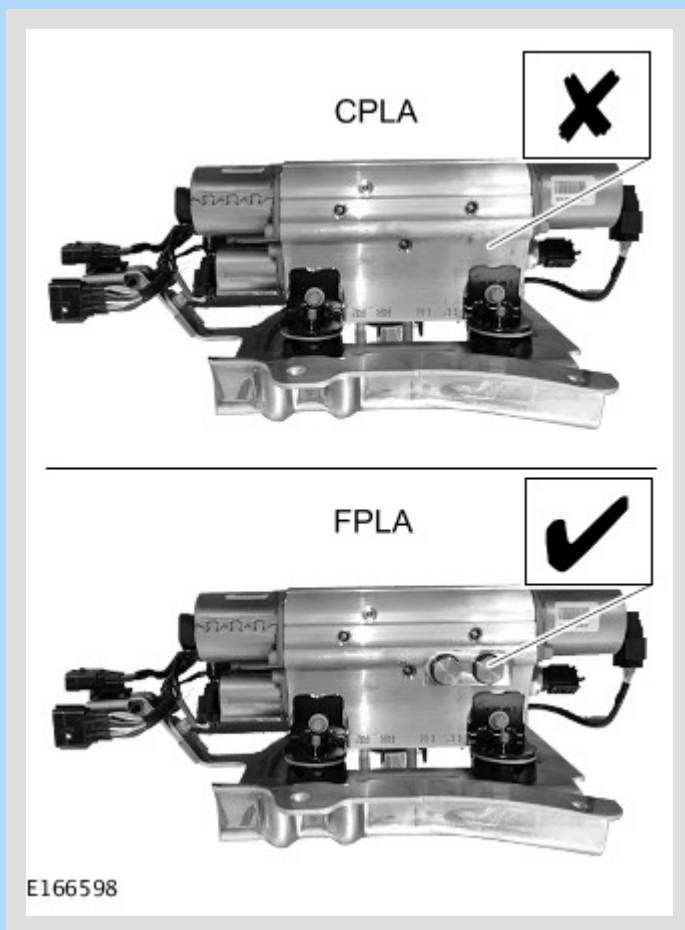
On strong customer complaint, confirm which level of valve block is fitted. Valve block shown removed for clarity.

Check the fitted valve block level (CPLA or FPLA).

- If the vehicle is fitted with the latest level (FPLA) valve block (✓), go to the Step 22.
- If the vehicle is not fitted with the latest level (FPLA) valve block (X), install new valve block (see TOPIx Workshop Manual section 204-06: Ride and handling optimization - Removal and installation - Valve block).
 - When all tasks are complete, go to the next Step.
