LTB01159NAS1

TECHNICAL BULLETIN

412-01: Climate Control

Climate Control Temperature Distribution Issues

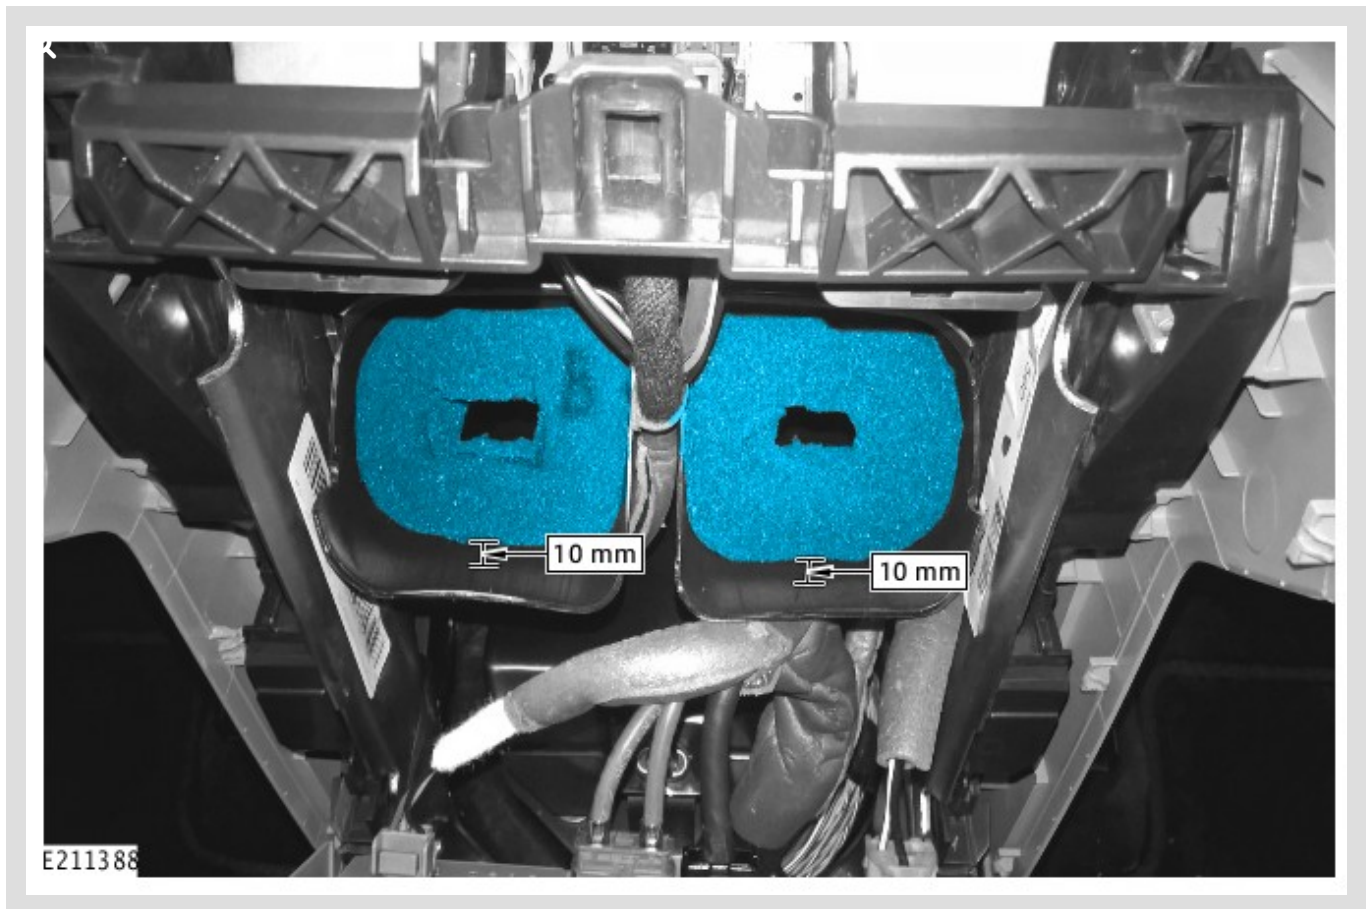
- 2

The temperature of the air blowing through the rear air vents may be noticeably higher than the air blowing through any other air vents, affecting the ability to set a constant comfortable temperature within the passenger compartment.

This may be caused by the required components not being installed within the floor console during vehicle production.

Measure from the flat edge of the footwell air duct.

Install 1 foam baffle into each footwell air duct.
