**TO: Mazda Dealership General Managers, Service Managers, and Parts Managers**  
**DATE: April 5, 2018**  
**SUBJECT: 2017 MX-5 Battery Discharging Concern**  
**Special Service Program (SSP) B5**

## **Special Service Program (SSP) B5 2017 MX-5 Battery Discharging Concern**

**ENGINE NO START DUE TO BATTERY DISCHARGE**

**Bulletin No.:** 01-004/18

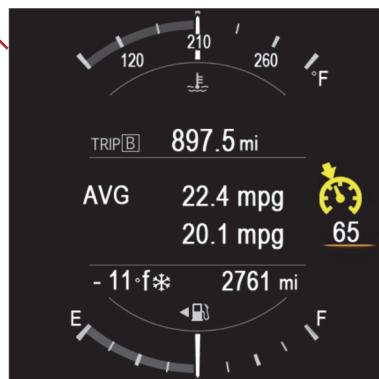
Figure A. MID with Cruise Control indicators ON

If the vehicle is turned off while the Cruise Control is ON (See yellow image in Figure A below), the microcomputer may not shift into sleep mode and an electric current will continue to flow to the MID display. With this condition, if the vehicle is left unused for a long period of time (approximately 10 days or more), the battery may discharge, resulting in an engine no-start condition.

Your Mazda dealer will reprogram the Instrument Cluster in your vehicle. The repair will be performed free of charge, and will take approximately one hour to complete; however, your Mazda dealer may need your vehicle for a longer period of time.

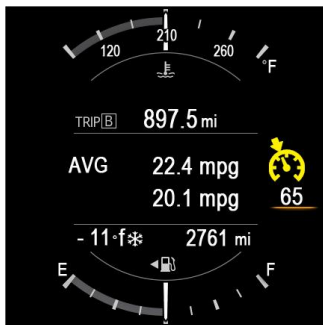
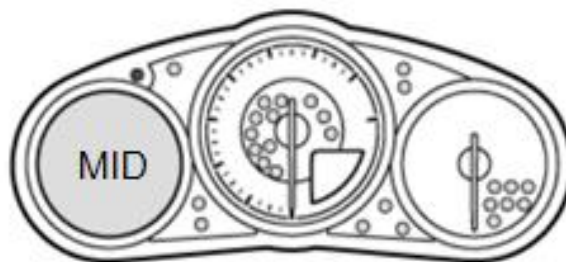
Some customers may complain about engine no start due to the battery being discharged. This may be caused by a software error with the speedometer which allows a dark current of 80 mA can continue to flow after the ignition is turned off. If the vehicle is not used for more than a week and left in this condition, the battery will discharge.

If the ignition is switched OFF while the Cruise Control is ON (one of the Cruise Control indicators is ON in the MID), the microcomputer does not shift into the sleep mode and an operation current of 80 mA will continue to flow.

To correct this concern, the software of the instrument cluster has been changed.

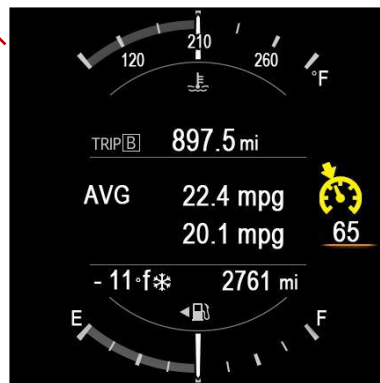
Figure A. With Cruise Control indicators ON

If the ignition is switched OFF while the Cruise Control is ON (one of the Cruise Control indicators is ON in the MID in Figure A below), the microcomputer does not shift into sleep mode and an operation current will continue to flow to the MID display. With this condition, if the vehicle is left unused for a long time (more than approximately 10 days), the battery may discharge, resulting in an engine no-start condition.

Dealers are to reprogram the Instrument Cluster with modified software.
