# Service Alert

<b>Subject:</b> <b>CENTER OF LEATHER SEAT BOTTOM SURFACE IS LOOSE/LIFTING</b>	<b>Service Alert No.:</b> SA-020/18
	<b>Last Issued:</b> 04/25/2018

2018 CX-5 vehicles equipped with leather seats

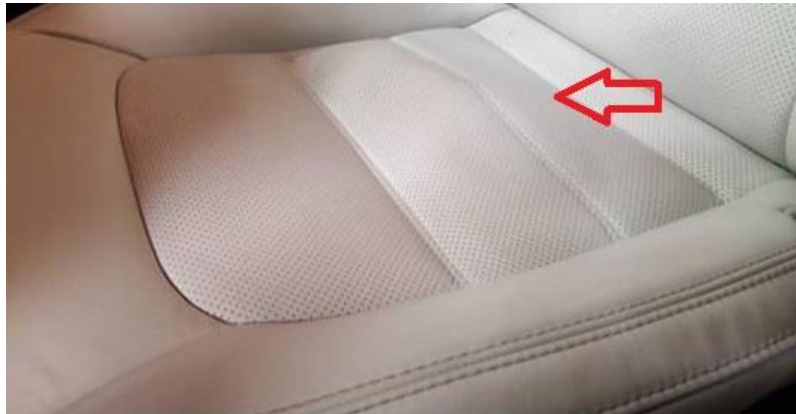
Some customers may complain that the center of the driver and/or passenger side seat bottom(s) are loose/lifting, as shown below.

**NOTE:** Not all vehicles will have the same color leather seats or have the same amount of looseness/lifting.

If you encounter a customer complaint for this concern, do not attempt any repairs at this time. Explain to the customer that a permanent repair is being developed by Mazda and will be available in approx. 60 - 90 days.
