# Technical Service Bulletin

<b>Subject:</b> <b>ENGINE MISFIRE DURING ACCELERATION WITH CHECK ENGINE LIGHT FLASHING AND DTCs P0302:00, P0303:00 AND/OR U0401:00</b>	<b>Bulletin No.:</b> 01-010/18
	<b>Last Issued:</b> 04/27/2018

2016-2017 CX-9 vehicles with VINs lower than JM3TC\*\*\*\*\*135222 (produced before Dec. 27, 2016)

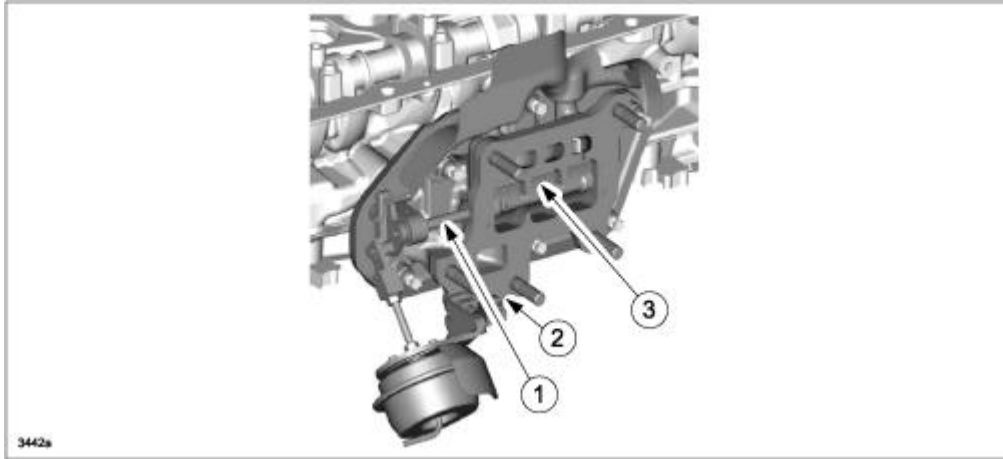
This concern may be caused if the exhaust manifold variable valve shaft (1) is out of alignment and/or the exhaust manifold variable valve housing (2) is out of shape. The exhaust manifold variable valve (3) then interferes with the housing and becomes stuck closed when the engine is hot.

To eliminate this concern in the future, the production processes and controls have been improved.

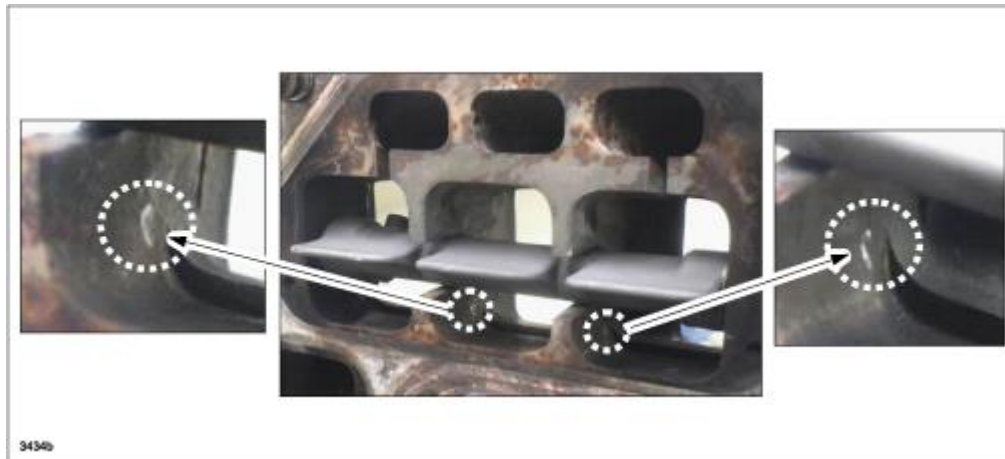
2. If one or both of the above conditions are met, remove the exhaust manifold and verify that there are contact mark(s) on the exhaust manifold variable housing caused by the variable valve, as shown below.

3. If contact mark(s) are found, replace the exhaust manifold with a modified one according to the instructions on MGSS online (EXHAUST SYSTEM REMOVAL/INSTALLATION [SKYACTIV-G 2.5T]).

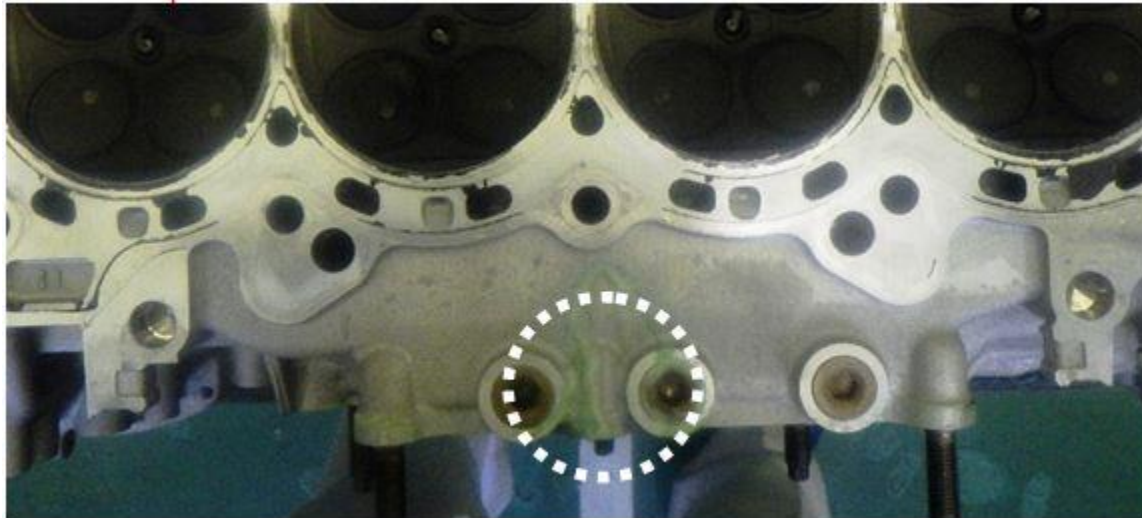
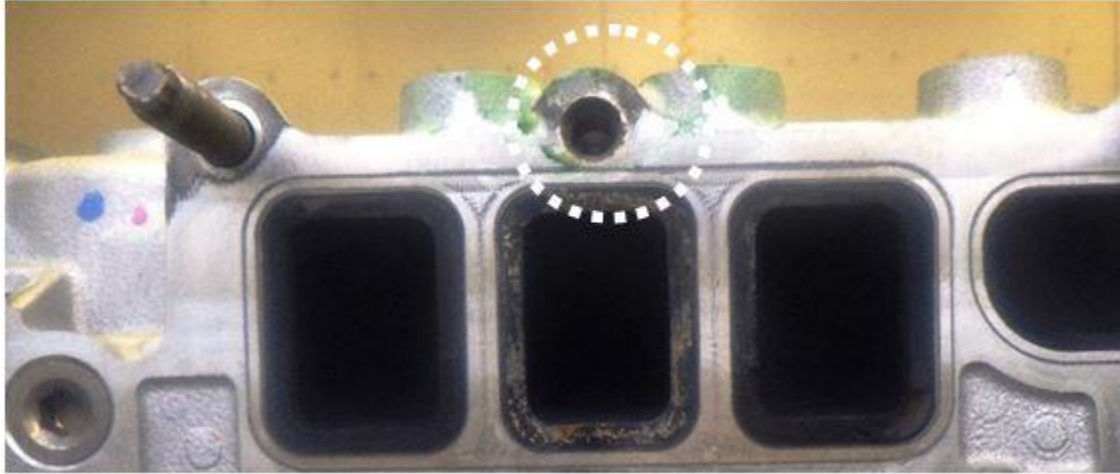
**CAUTION:** When tightening nuts, do not allow the stud bolt to rotate over 270 degrees, otherwise, it could cause the cylinder head to crack, as shown below. If cylinder head is cracked, replace it with a new one. (TOP VIEW)

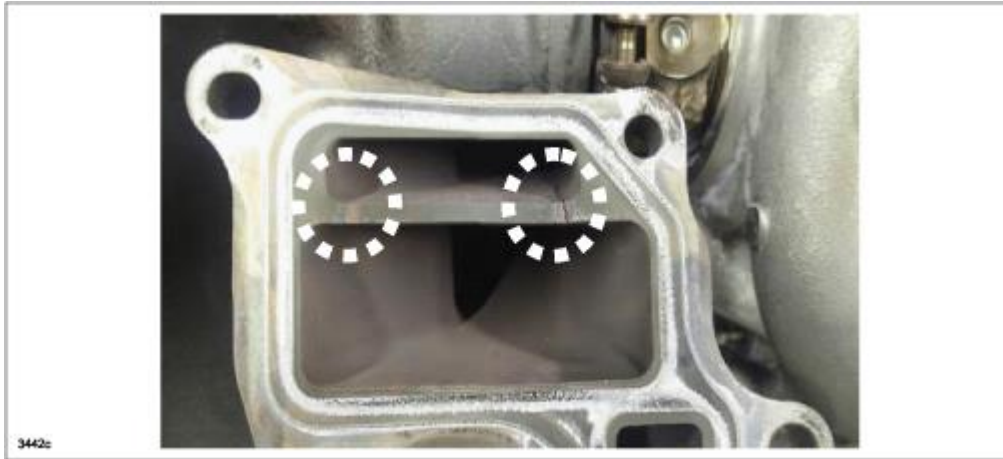
**NOTE:** There may be a crack found in the turbocharger housing, as shown below. The crack does not affect engine performance or cause any noise, so turbocharger replacement is not necessary.
