Technical Service Bulletin

DRIVER AND/OR PASSENGER SEAT WARMER(S) INOPERATIVE - (CLOTH SEATS ONLY)

Bulletin No.: 09-017/18

2013-2016 CX-5 vehicles equipped with cloth seats

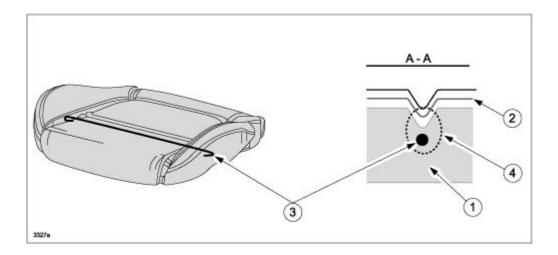
Some vehicles may exhibit inoperative driver and/or front passenger side seat warmer(s) in any mode (High, Mid and Low). This may be caused by repeated load applied to the seat cushion (1) while the seat is occupied. A section of the heater mat (2) just above the reinforcement rod (3) in the cushion pad contacts internal heater mat wire and causes damage (4).

- 1. Verify the customer concern.
- 2. Replace the seat cushion pad(s) according to the instructions on MGSS online FRONT SEAT CUSHION TRIM REMOVAL/INSTALLATION.

- A new seat cushion pad is available with a repositioned internal heater mat wire to prevent contact with the reinforcement rod.
- 2016 CX-5: There is no modified seat cushion available for the front passenger side seat, only the driver's side seat cushion is available.
- 3. Verify the repair.
