Technical Service Bulletin

Mazda North American Operations
Irvine, CA 92618-2922

Subject: STAINS FOUND ON PAINT DURING PDI	Bulletin No.: 09-021/18
	Last Issued: 04/05/2018

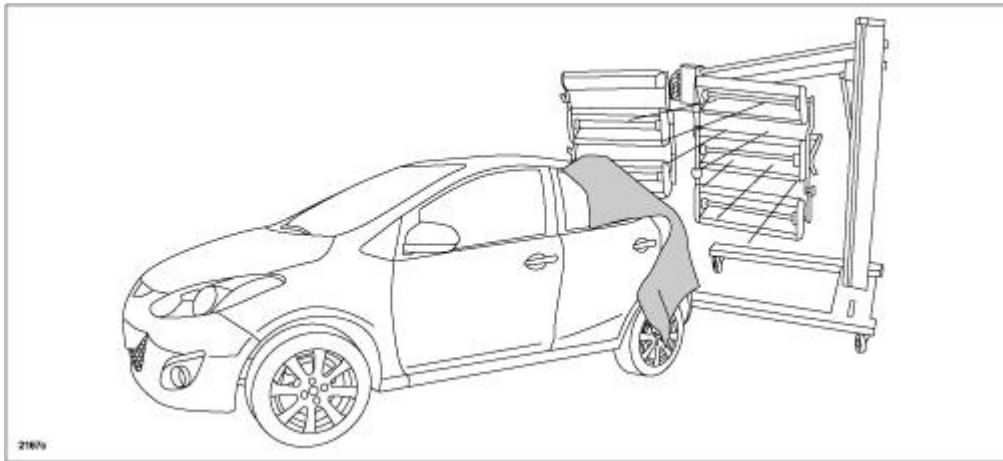
PROCEDURE FOR USING INFRARED DRIER (for larger stains):

6. Mount an infrared drier approx. 31.5 inches (80 cm) away from the surface of the stained area.

7. Set the temperature of the infrared drier to 140~158° F (60~70° C) and apply heat for a maximum of **60 minutes**.

CAUTION: DO NOT apply heat for more than 60 minutes or damage to the body panel surface, plastic or rubber parts may occur.
