# DOMETIC HEATING FURNACES

## Furnace Limit Switch Service Bulletin

| Model | Serial Number Range |
| All Small & Medium Furnaces (AFS, AFM, DFS, DFM) | 73985322 – 81099541 |

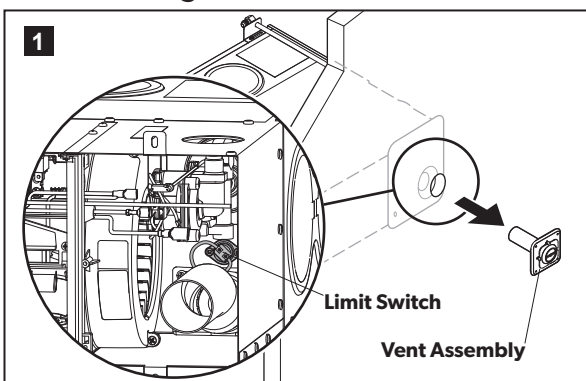
### 1.1 Examining the limit switch wires

After removing the vent assembly, look into the exhaust vent tube area. If visual evidence exists that the limit switch wires are melted or laying on the exhaust vent tube, contact the Dometic Technical Service department at 866-869-3118 to obtain authorization for removal of the furnace for replacement, prior to repairing any wires or continuing with a field repair. The field repair involves sliding a 7" long, high-temperature rated, fiberglass sleeve over the exhaust tube. The field repair kit became available in March, 2018. The field repair kit part # is 31389, Flat Rate Time is .5 and the fault code is 617.25.
