## SERVICE BULLETIN

| Reference number: | SB-15-1009 | Issued: 05 April, 2018 |
| Subject: | Aston Martin infotainment (AMi) II - SW update | |
| Model(s): | V8 Vantage (all variants), V12 Vantage (all variants), DB9 (all variants), Vanquish, Rapide (all variants) | |

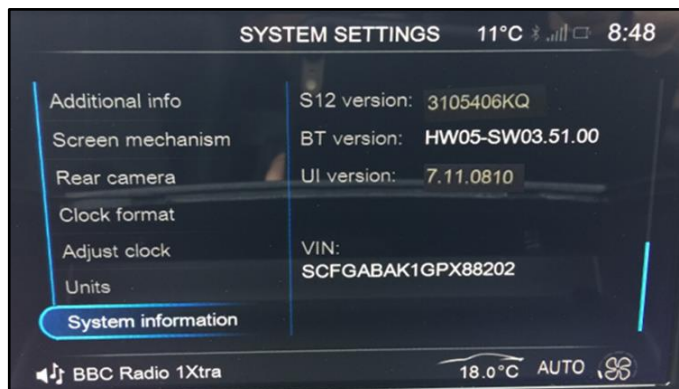
Figure 1

1. Start the infotainment system.
2. Select the "System Settings".
3. Check the version numbers that are shown in the System information (refer to Figure 1).

4. If the software is already at the specified levels, (refer to Figure 1) the software has already been updated. Do not do the procedures that follow if the software has already been updated.

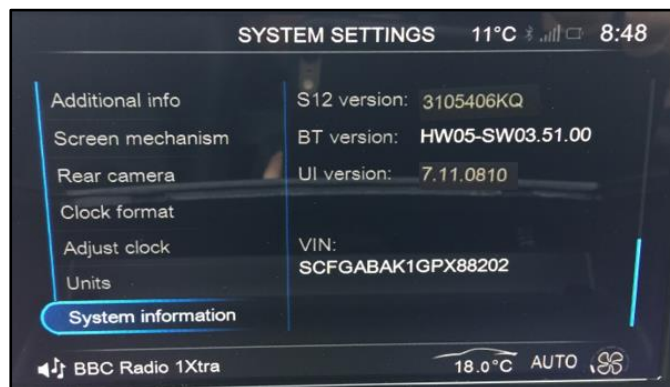
**Figure 7**

32. When finished, make sure that the part numbers are:

- **S12 version:** 3105406KQ
- **BT Version:** HW05-SW03.51.00
- **UI version:** 7.11.0810

33. If the update was apparently successful but the version numbers are still not correct, do the procedure again from step 5. It is possible that you must do this more than one time.
34. If the software levels shown are still incorrect, speak to AMTech.
35. If the software levels shown are correct remove the USB device from the ICU.
36. Set the ignition to off and remove the key from the docking station.
37. Lock the vehicle and wait 30 seconds
38. Unlock the vehicle. The update process is now complete.
