## SERVICE ACTION

Reference number:	SA-15-1086	Issued: 6 March, 2018
Subject:	Vanquish Ultimate Splash Screen Update	
Model(s):	Vanquish	
VIN range:	Refer to attached VIN list	
Applicable to:	All Dealers	
Distribute to:	After Sales Manager Executive Manager Service Manager Sales Manager	Warranty Staff Technician(s) Parts Staff

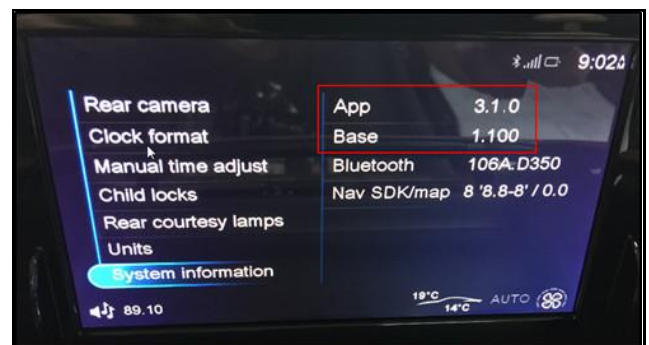
Figure 1

7. If the infotainment system identifies a USB storage device with a .update file, the display screen will change to black. A text message related to the update will display.
8. The update procedure will start automatically. The procedure will continue for two and a half minutes and will restart the Infotainment Control Unit twice.
9. The automatic update procedure is complete when the infotainment system has started again and displays the main menu.
10. Set the ignition to Off.
11. Remove the USB storage device.
12. Get out of the vehicle and lock it.
13. Wait for a minimum of two minutes. The Infotainment Control Unit will go into full sleep.
14. Unlock the vehicle.
15. Set the ignition to On.
16. Use the joystick to navigate to the System Information page. The page will display the updated Part Numbers for the App and for the Base (refer to Figure 1).
