Service Update

18009 Service ECM Incorrect Bootloader Version

Reference Number: N172126910

Make	Model	Model Year		RPO	Description
		From	To		
Chevrolet	Malibu	2018	2018	LFV	1.5L Engine

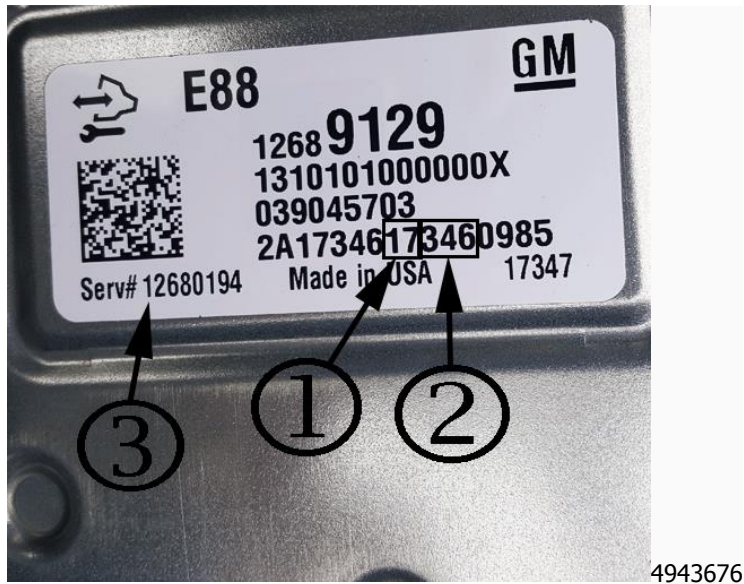
4. Inspect the part number on the ECM.
 - If the service part number found in the bottom left of the label (3) is 12680194, replace the ECM with a new part. Refer to step 5.
 - If the service part number (3) is 12691559, no further action is required. Refer to step 6.
5. Replace the ECM. Refer to *Engine Control Module Replacement* in SI. Ensure the Julian date of the new ECM starts with 17 (1) and ends in a number greater than or equal to 294 (2), OR that the Julian date starts in 18 (1) or later. If the new ECM does not have a Julian date meeting these requirements, order another ECM and return the noncompliant ECM to General Motors.
6. If the ECM was not replaced, reinstall the ECM and the upper ECM bracket.

3. **Without disconnecting the ECM connectors**, slide the ECM out of the bracket so the label on the rear of the ECM is visible.
