Service Bulletin

Bulletin No.: 16-NA-147

Subject: Brake Pedal Squeak Noise Heard When Applying and Releasing Brake Pedal/Cruise Control Inoperative or Disengaged

Brand:	Model:	Model Year:		VIN:		Engine	Transmission:
Branu.		from	to	from	to	Engine:	
Chevrolet	Volt	2016	2017

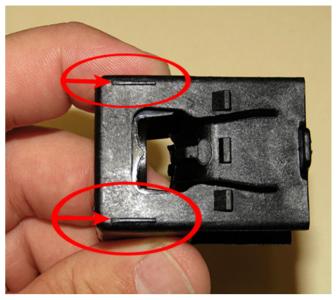
4573875

Note: The new retainer has two raised ears on both sides located on the front, which will cause an interference fit when installing.

- 4. Remove and **DISCARD** the brake pedal push rod retainer (1) from the brake pedal (2).
- 5. Install the **NEW** brake pedal push rod retainer into the brake pedal by hand using reasonable effort.
