# Service Bulletin

Bulletin No.: 16-NA-159

**Subject:** Squeak, Buzz and/or Rubbing Noise from Steering Column Area

Brand:	Model:	Model Year:		Breakpoint:	Engine:	Transmission:
		from	to			
Chevrolet	Colorado	2015	2018			
GMC	Canyon	2015	2018

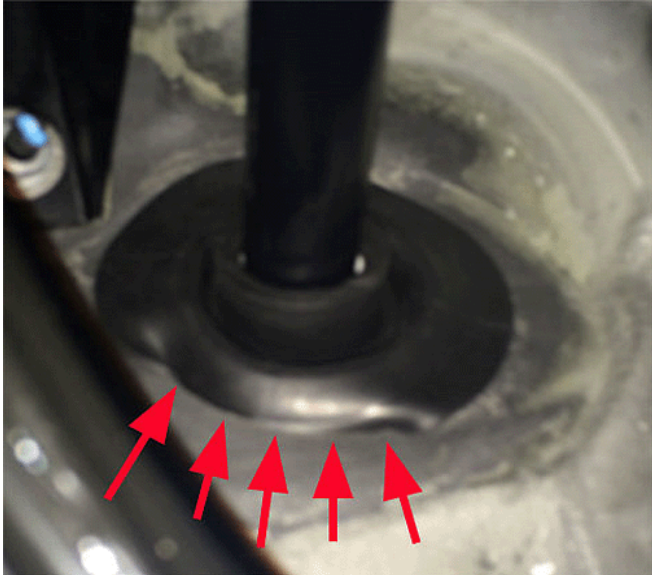
4512167

<b>Involved Region or Country</b>	North America
<b>Condition</b>	Some customers may comment on a squeak, buzz and/or rubbing noise coming from the steering column area.
<b>Cause</b>	This condition may be due to the inner and/or outer intermediate steering shaft boots (seals) being out of position.

Inspect the intermediate steering shaft inner and outer boots (seal) for being out of position as shown above. If the boots are out of position, use a flat trim stick to properly seat the boots.
