# Service Bulletin

Bulletin No.: 17-NA-411

**Subject:** Headliner Sag at Front

Brand:	Model:	Model Year:		VIN:		Engine:	Transmission:
		from	to	from	to		
Chevrolet	Equinox	2018	2018			All	All
GMC	Terrain	2018	2018

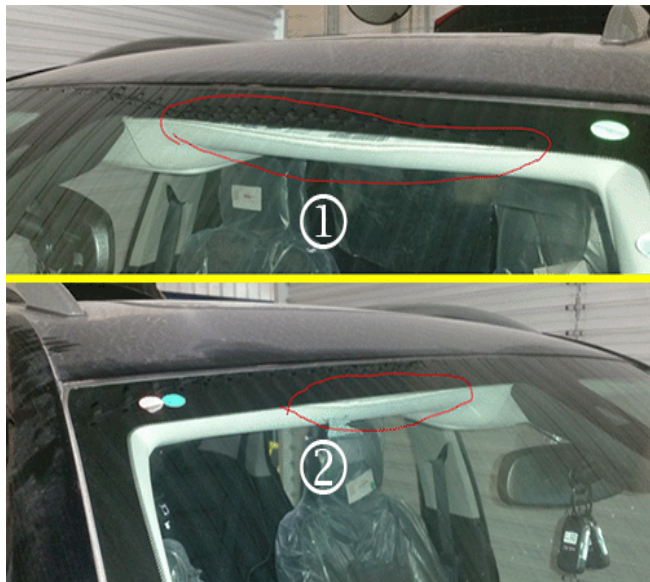
4892985

- Standing at front of vehicle, inspect both right and left sides for appearance of the sagging condition.

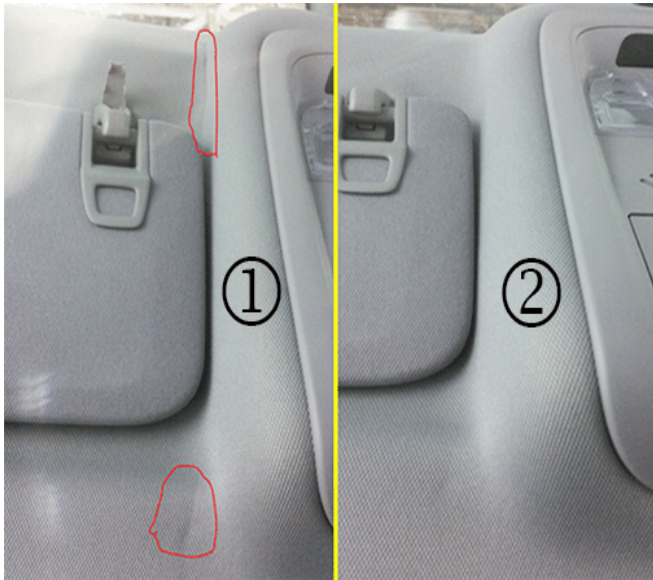
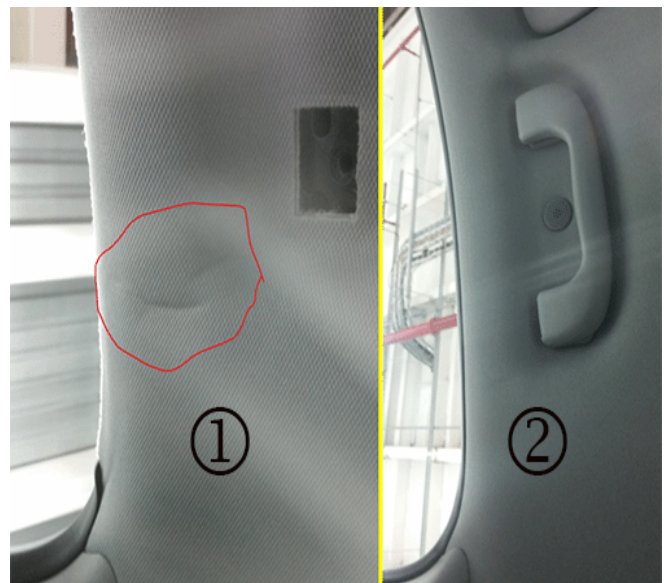
**Note:** The graphics above show examples of minor headliner wrinkling (1) that may occur during the repair process. These wrinkles should disappear in a short time once all the trim components are reinstalled (2). In some cases manually rubbing the headliner in these areas will help speed up their disappearance.
