Service Bulletin

Bulletin No.: 16-NA-004

Subject: Intermittent Multiple IPC Warning Lamps Illuminated, Loss of Power Steering Assist, No Crank/No Start, Service Power Steering Message on Drivers Information Center (DIC), Malfunction Indicator Lamp (MIL) Illuminated, Multiple HSLAN U-Codes Set

Brand:	Model:	Model Year:		VIN:		Engine:	Transmission:
		from	to	from	to		
Chevrolet	Equinox	2012	2017			2.4L (LEA)	
GMC	Terrain

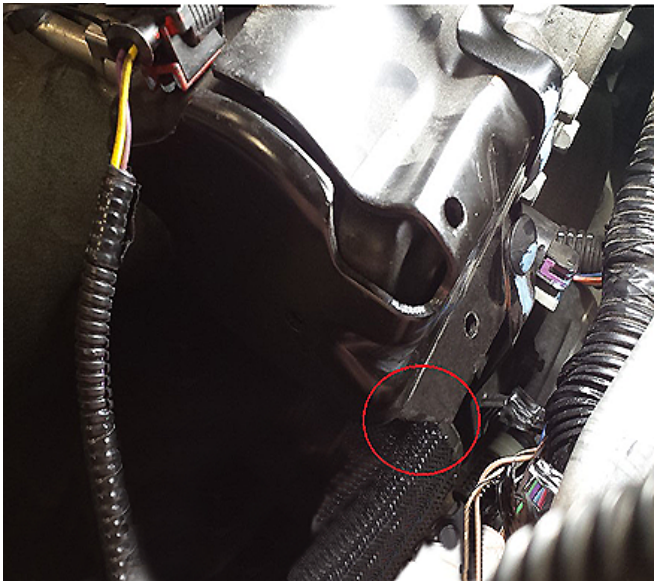
Involved Region or Country	North America and N.A. Export Regions
Condition	<p>Some customers may comment on the following conditions:</p> <ul style="list-style-type: none"> • Intermittent multiple IPC warning lamps illuminated • Loss of power steering assist • No crank/no start. • Service Power Steering message on DIC • MIL illuminated <p>Some technicians may find one or more HSLAN U-Codes set.</p>
Cause	This may be caused by the engine wiring harness chaffing on the edge of the fuel pump cover.
Correction	<div style="text-align: right; margin-bottom: 10px;">4363219</div>

<ol style="list-style-type: none"> 1. Inspect the engine wiring harness conduit and wires for chaffing. 2. Repair the wires per the <i>Wiring Repairs</i> procedure in SI. 3. Wrap the engine wiring harness with Polyester Electrical/Anti-Abrasive Tape (PET) or equivalent anti-abrasion tape. 4. Using a small metal file, remove any burrs and sharp edges along the fuel pump cover edge in the area illustrated above. 5. Position the engine wiring harness away from the edge of the fuel pump cover.
