Service Bulletin

Bulletin No.: 16-NA-203

Subject: Active Shutters Inoperative During Cold Ambient Temperatures, Malfunction Indicator Lamp (MIL) Illuminated - DTC P059F Set Current or in History

Brand:	Model:	Model Year:		VIN:		Engine:	Transmission:
				from	to		
Chevrolet	Volt	2016	2017

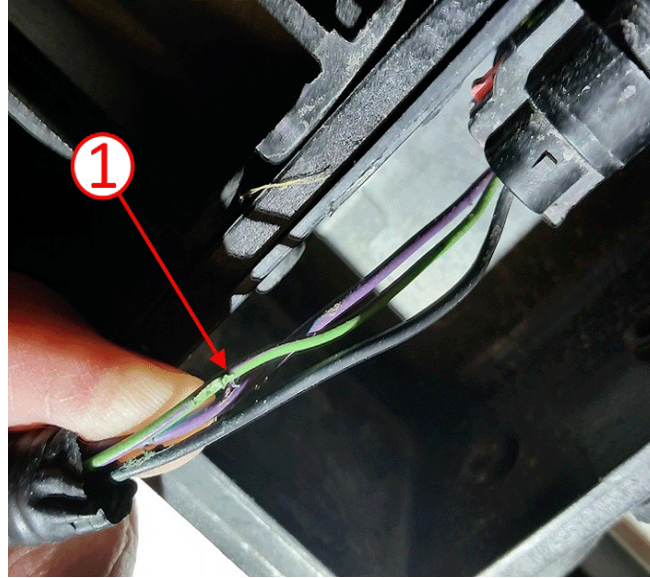
4538157

Inspect the active shutter wiring harness for any signs of chafing (1).

- If any chafing was found on the wiring harness, the harness must be repaired as needed.
- If the wiring harness has been found in working order and does not need repairing, using care, perform inspection on the shutters for any signs of snow, ice and/or damage.
