# Service Bulletin

Bulletin No.: 16-NA-303

**Subject: Radio Display Blank, Instrument Cluster Gauges Inoperative and/or Steering Stiff**

Brand:	Model:	Model Year:		VIN:		Engine:	Transmission:
		from	to	from	to		
Chevrolet	Malibu	2013	2016

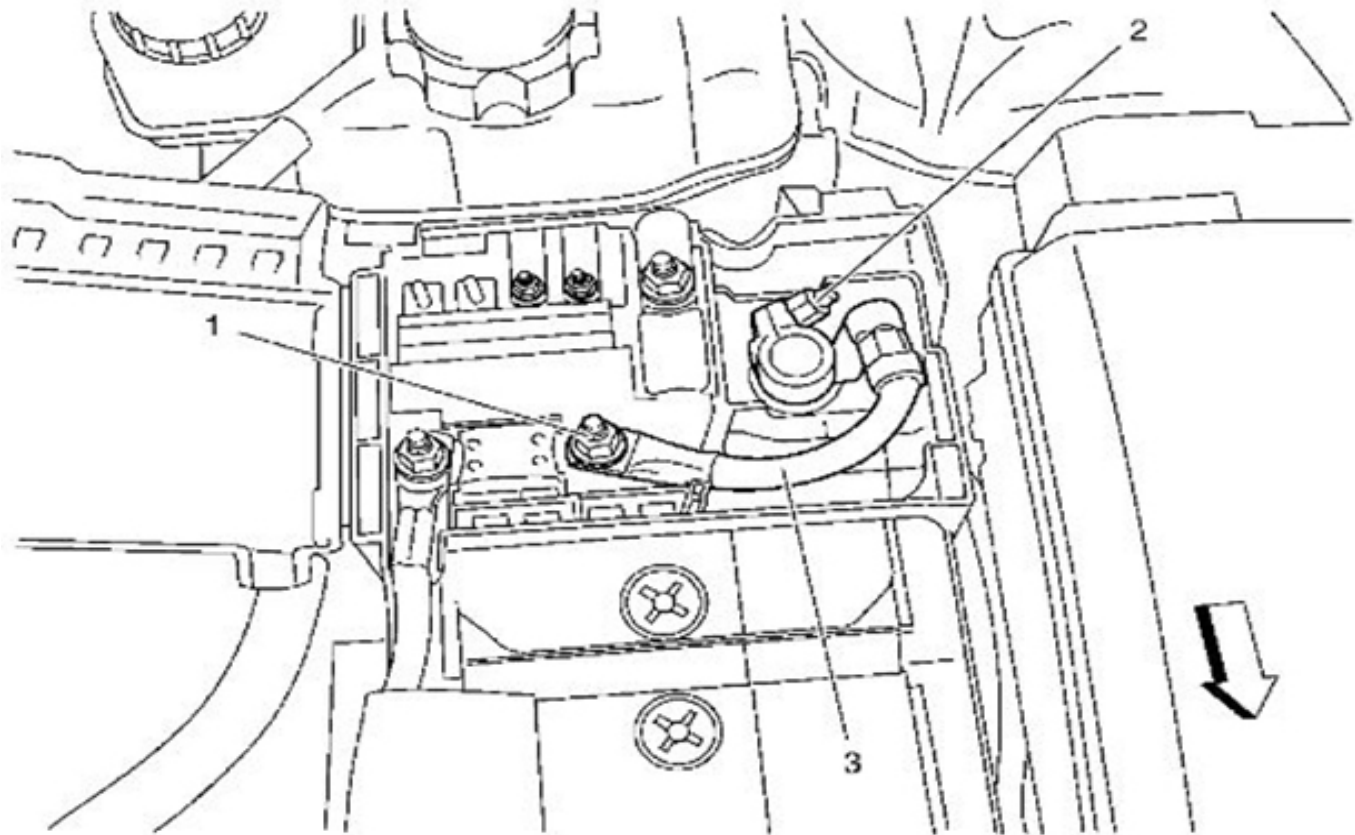
4855770

<b>Involved Region or Country</b>	North America and N.A. Export Regions
<b>Additional RPO</b>	Equipped with Electric Power Steering (NJ1) without Stop-Start (KL9)
<b>Condition</b>	Some customers may comment that the radio display goes blank, the instrument cluster gauges are inoperative and/or the steering is stiff. This may be an intermittent concern, but more likely to duplicate when driving at slower speeds, such as in a parking lot and/or making a turn.
<b>Cause</b>	This condition may be caused by reduced system voltage.
<b>Correction</b>	Perform the Service Procedure below:

1. Using a DVOM, perform a voltage drop for the positive side battery cable (3):
  - Set the DVOM to Min/Max voltage.
  - Apply the DVOM leads at the positive cable clamp (2) and the positive cable terminal (1) at the UBEC.

- Start the vehicle.
  - Record the maximum voltage.
 ⇒ If the voltage exceeds 200 millivolts, replace the positive battery cable.
2. Disconnect the battery negative cable. Refer to *Battery Negative Cable Disconnection and Connection* in SI.
